第十堰調査区域詳細図

調査区域 19 植石コンクリト(1/2)

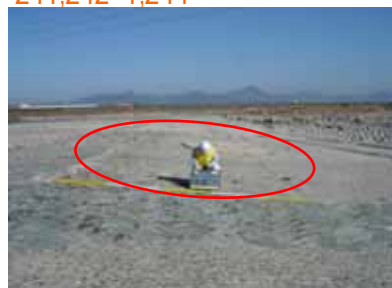
**破損**  
241,242-1,244

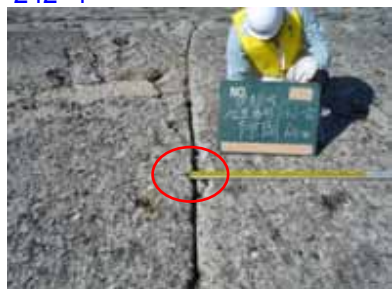
**隙間**  
242-4

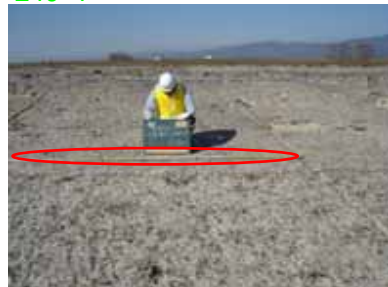
**クラック**  
242-2

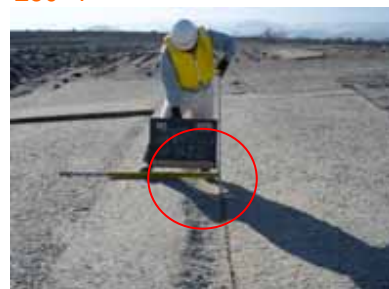
破損  
250-1

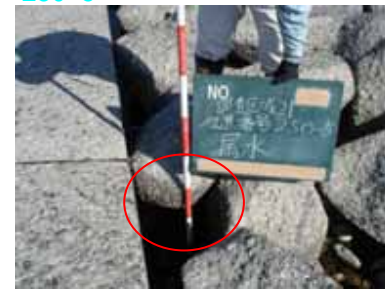
漏水  
250-5

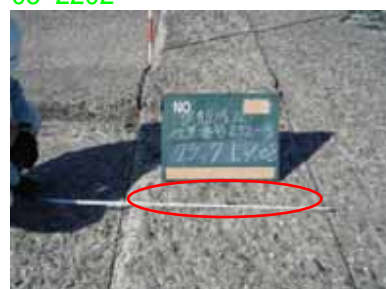
クラック  
05-2201

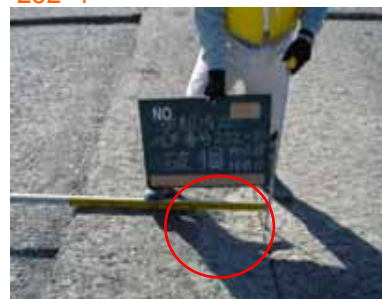
破損  
252-1

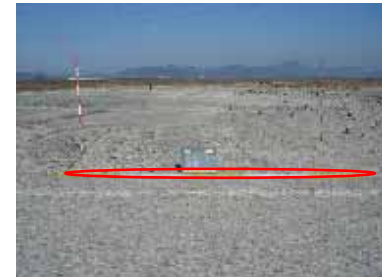
クラック  
256-2

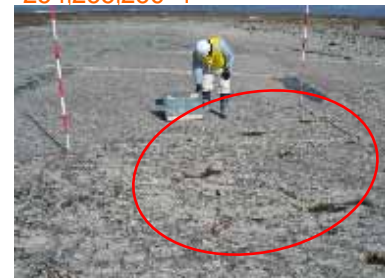
破損

254,255,256-1

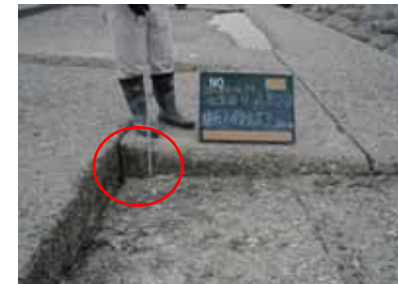
沈下

285-2

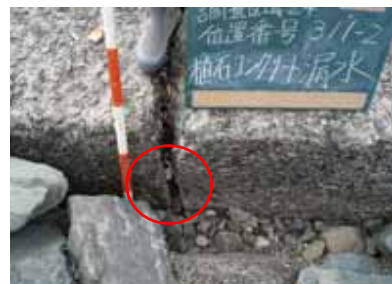
漏水

311-2

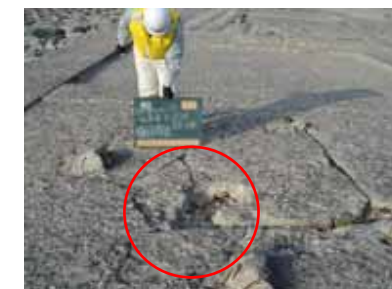
破損

334

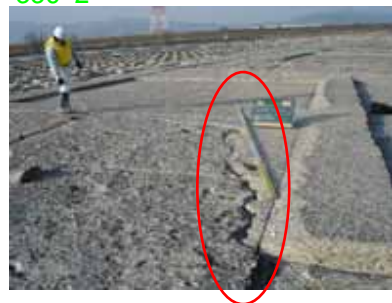
クラック

336-2

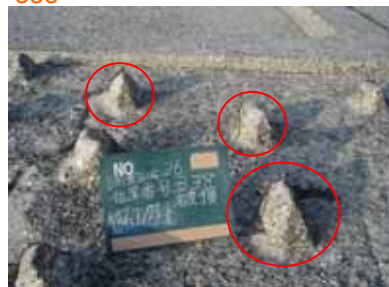
破損

338
