第十堰調査区域詳細図

調査区域 36 植石コンクリート(1/3)

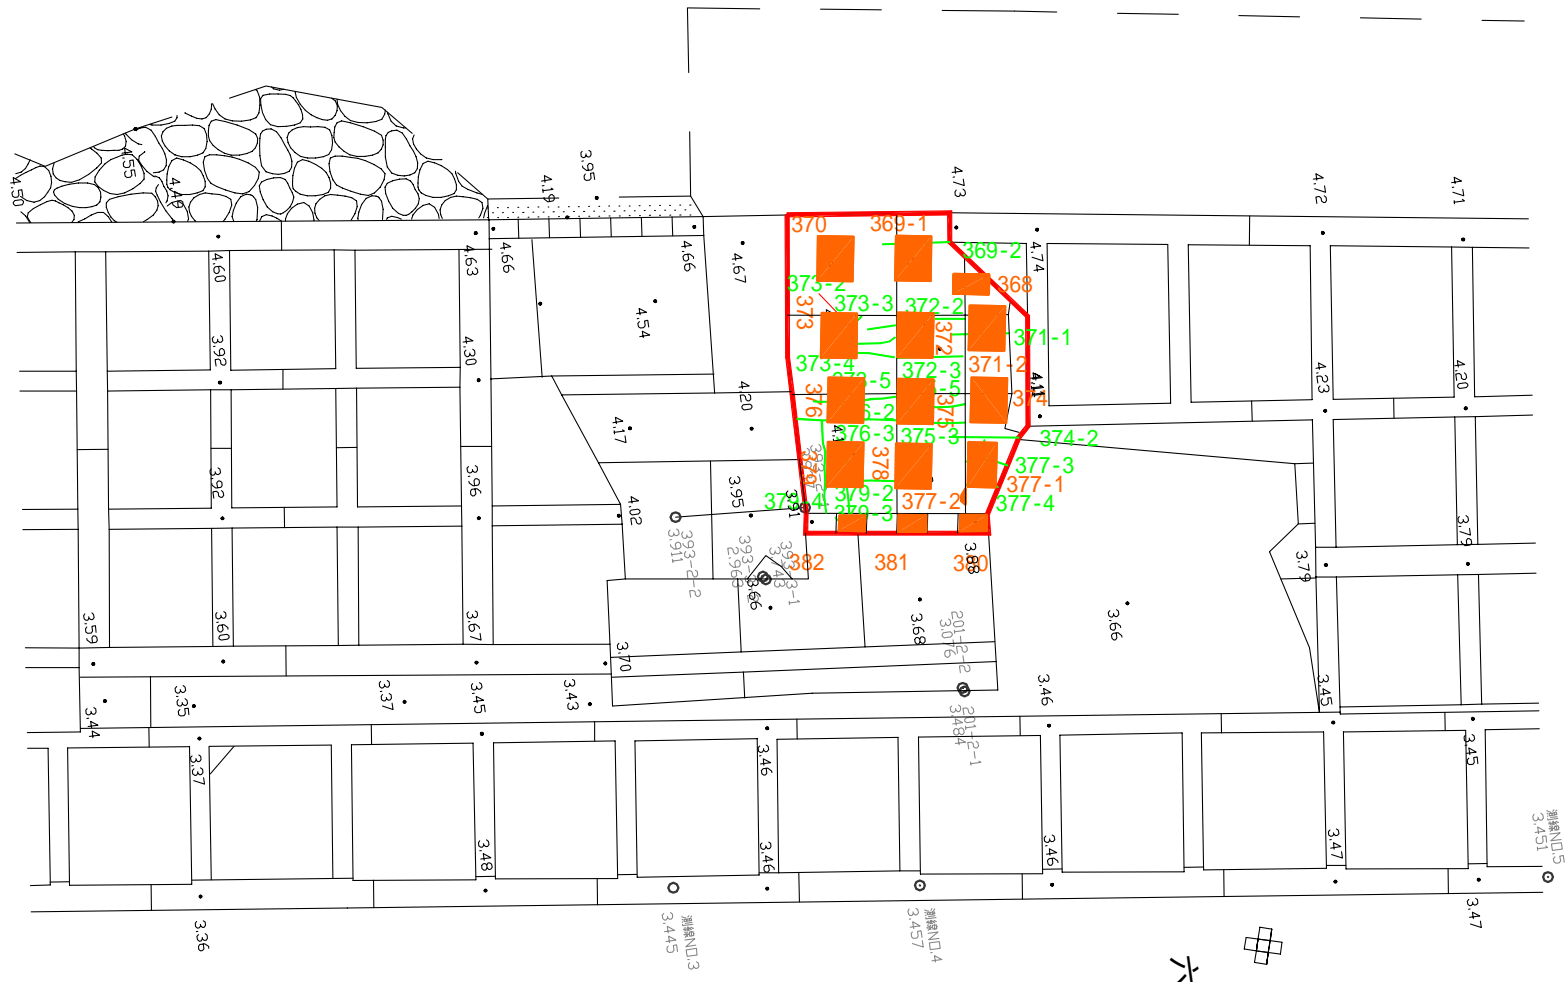
第十堰調査区域詳細図  
調査区域 36 植石コンクリート(2/3)

クラック

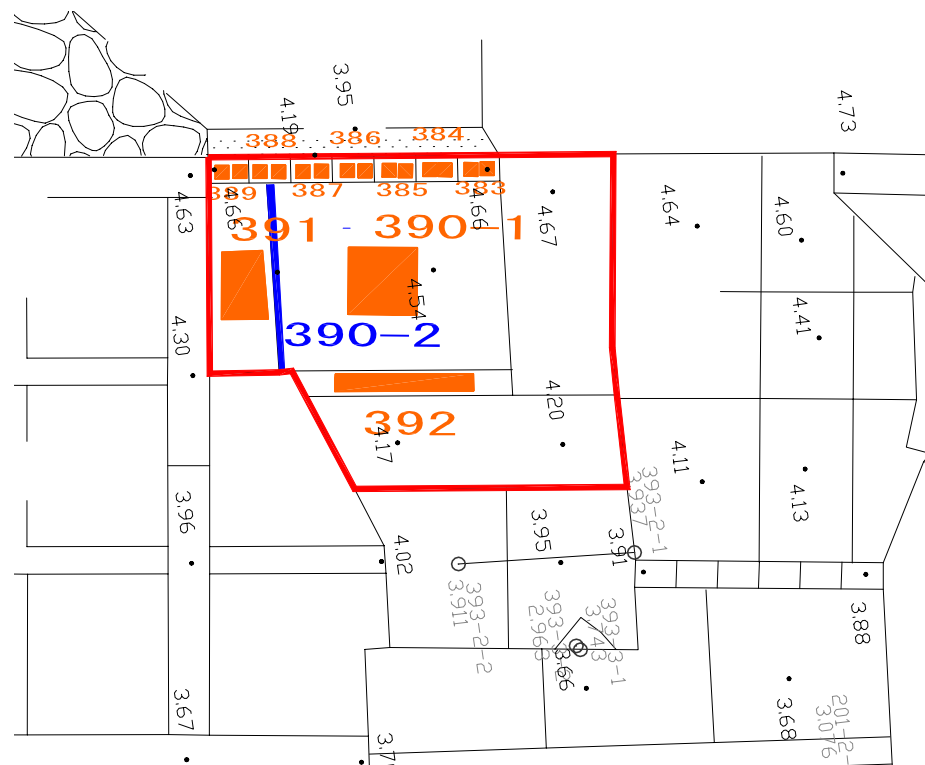
調査区域 37 植石コンクリト

破損 隙間

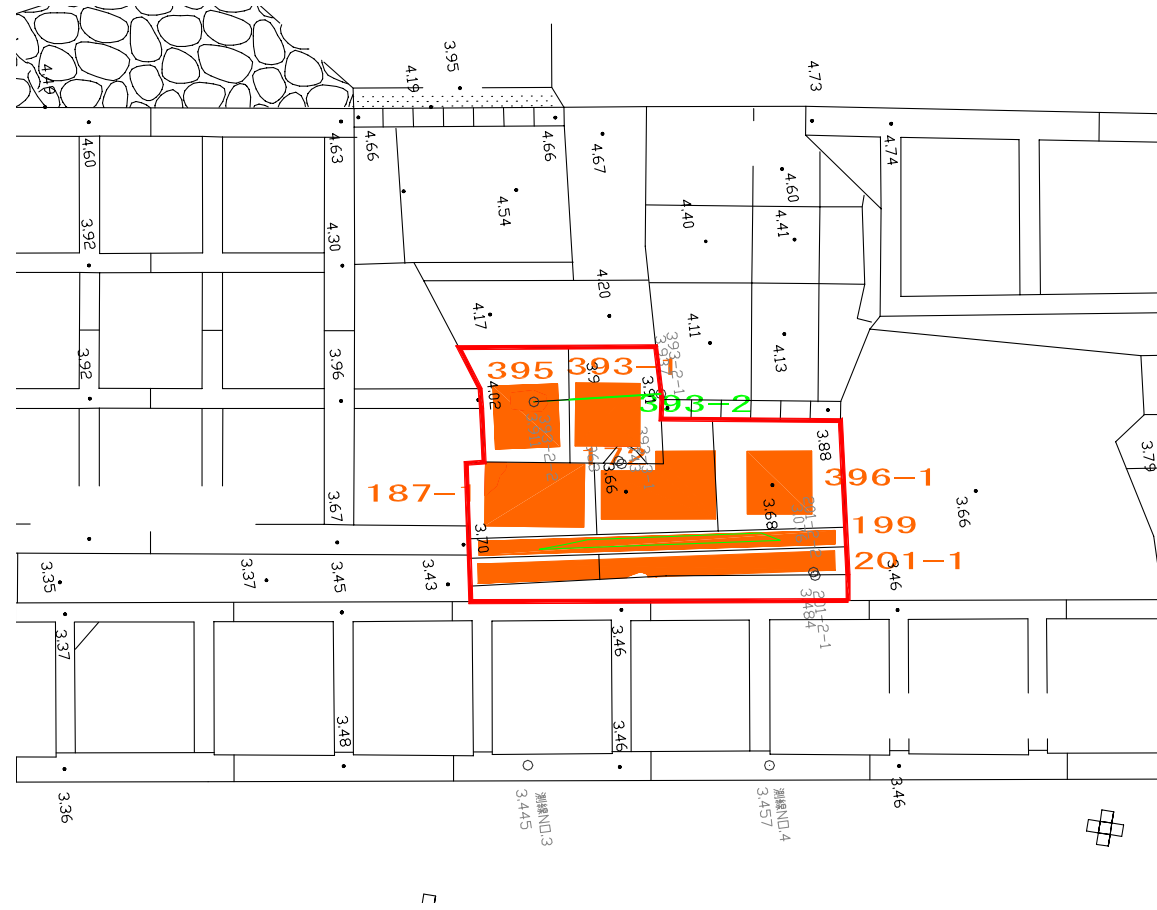
調査区域 38 植石コンクリート

破損

クラック

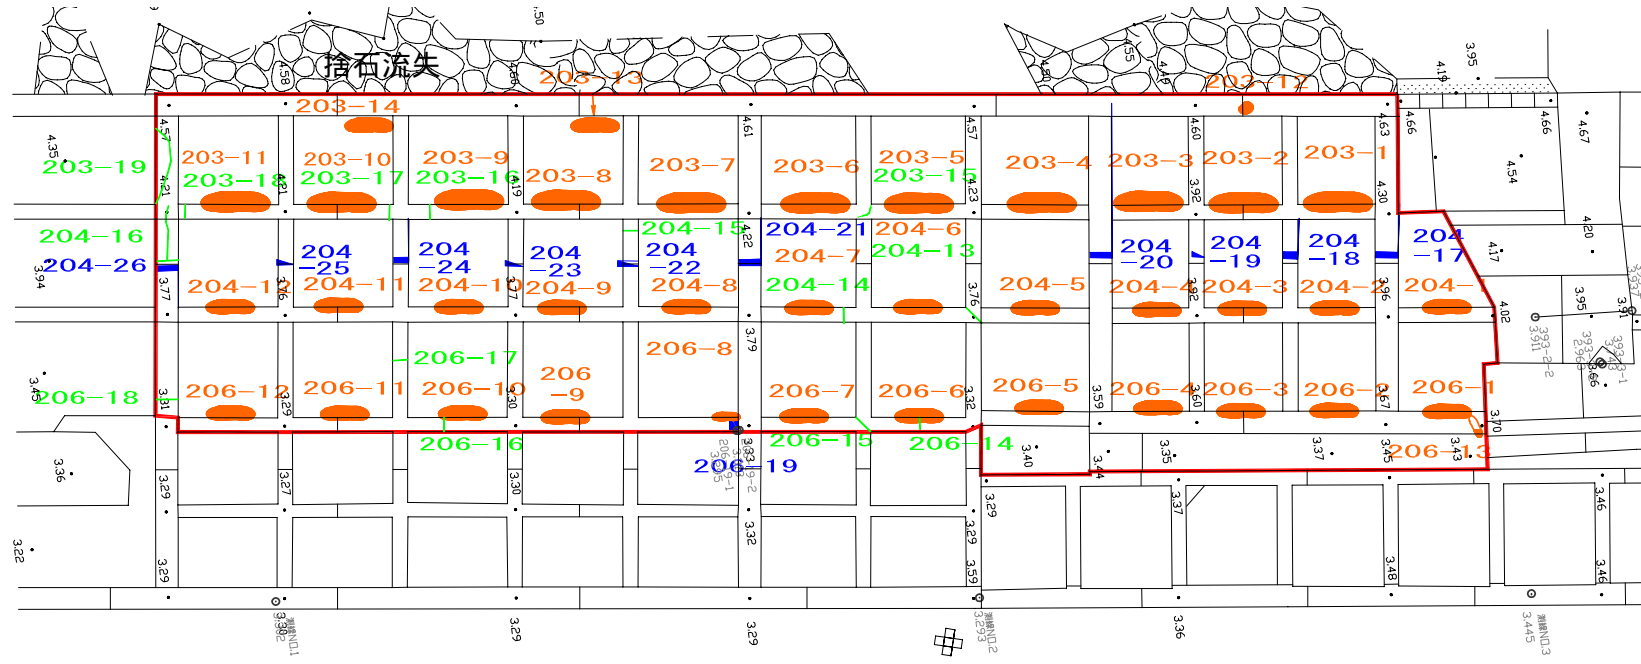
調査区域 40 コンクリート張 (1/4)

破損

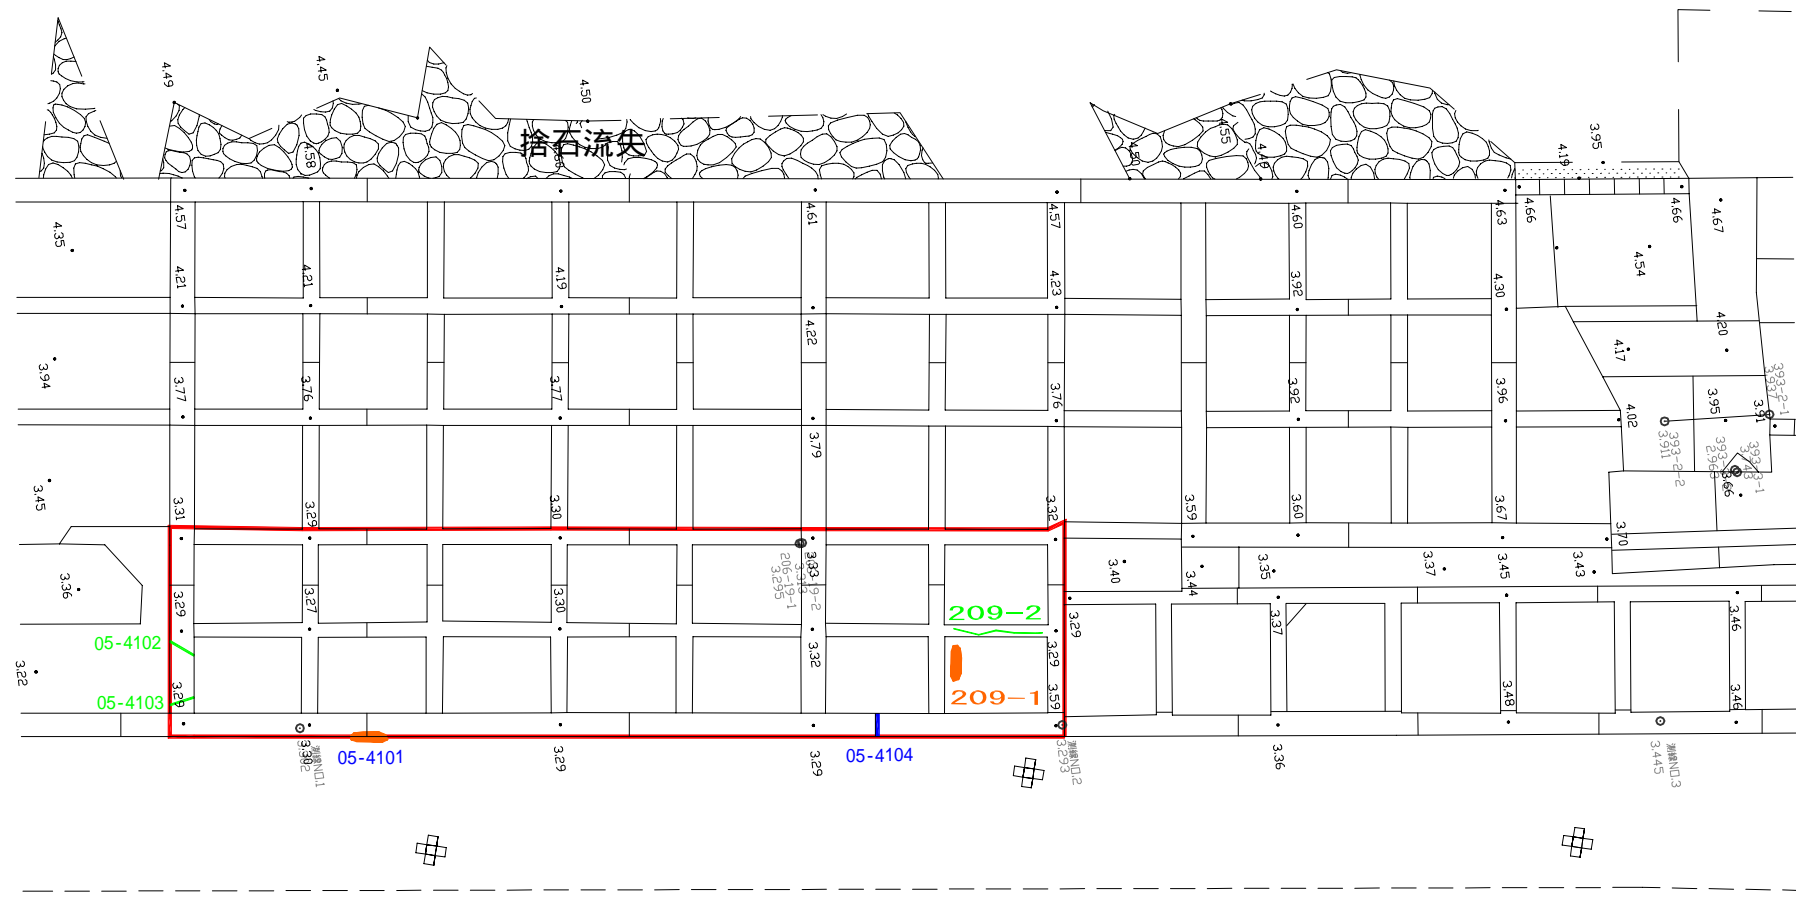
## 調査区域 41 コンクリート張

破損

クラック

隙間

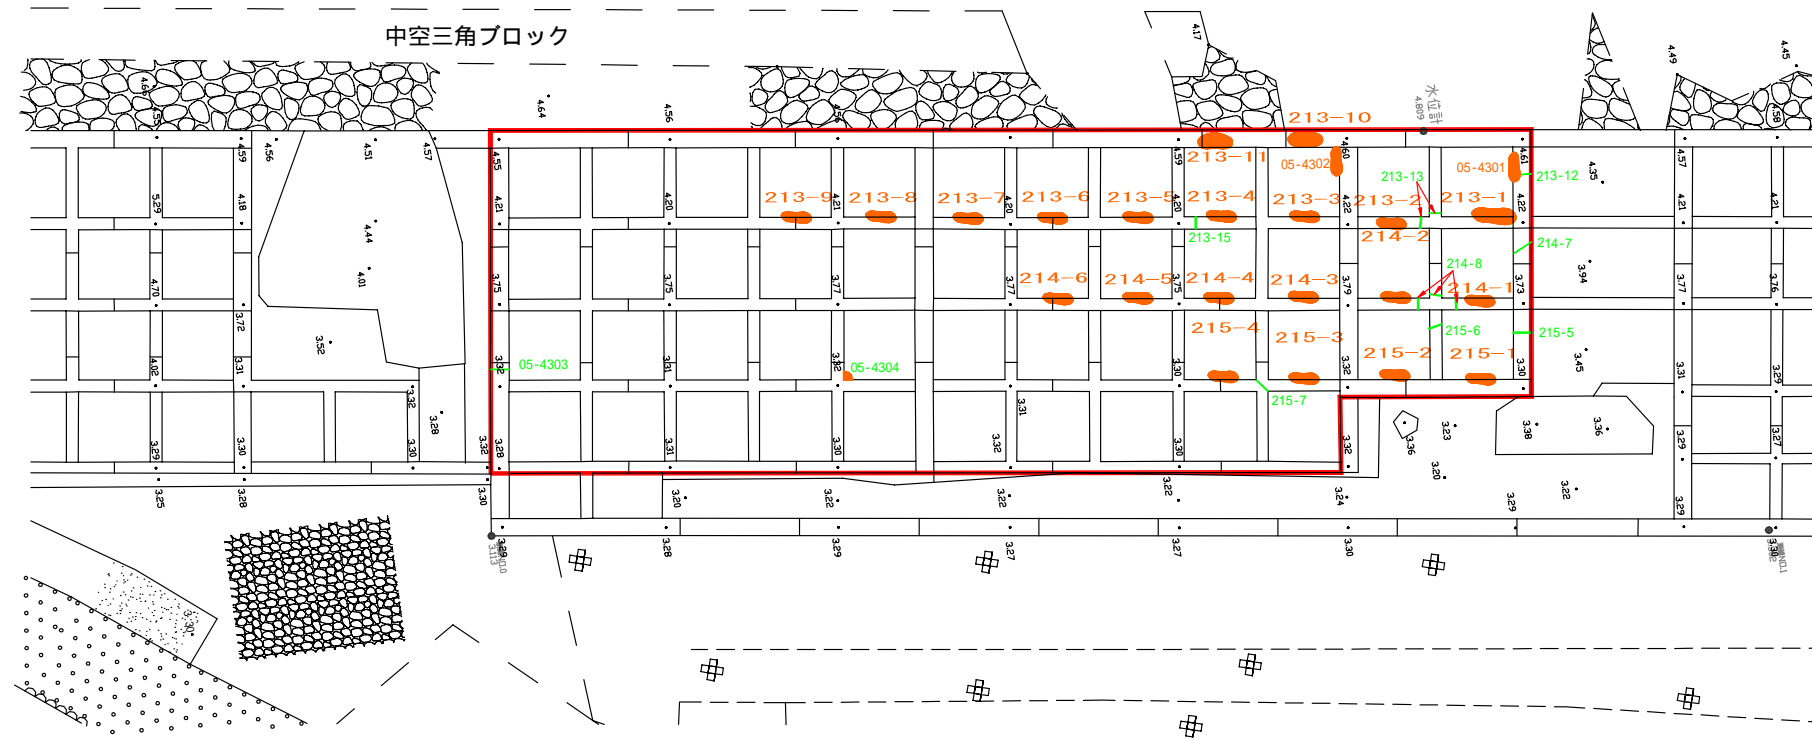
調査区域 43 コンクリート張 (1/3)

破損

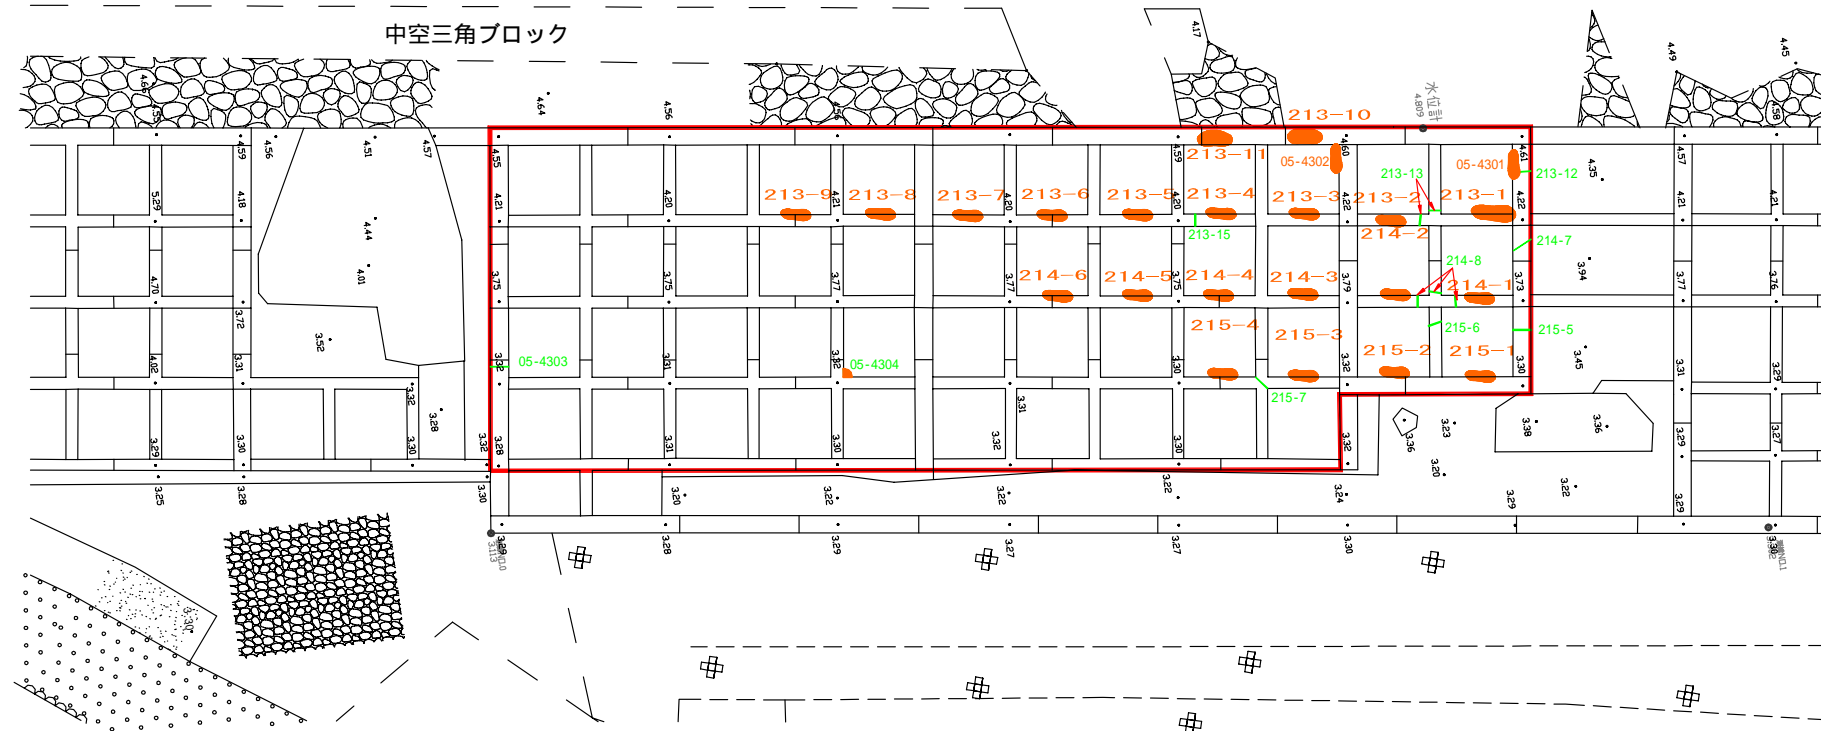
調査区域43 コンクリート張 (2/3)

破損
