第十堰調査区域詳細図

調査区域 8 魚道

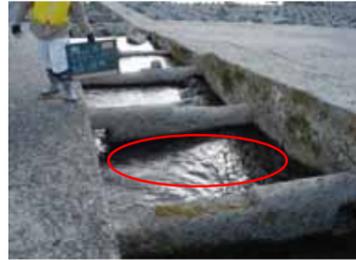
137

破損

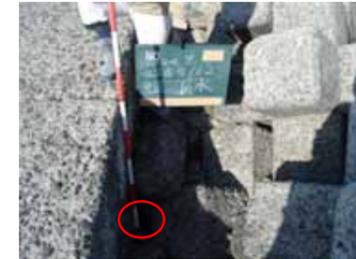
162-2

漏水

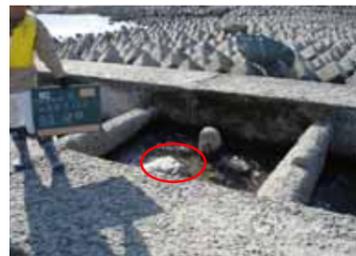
163-2

隙間

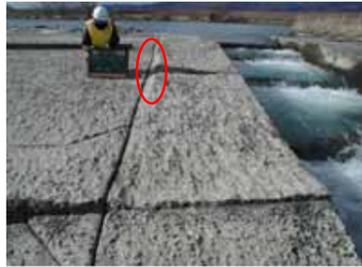
164-1

破損

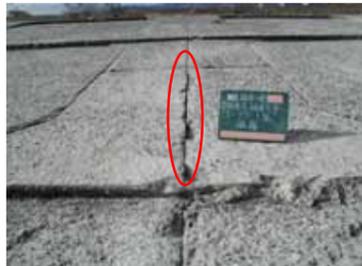
164-2

クラック

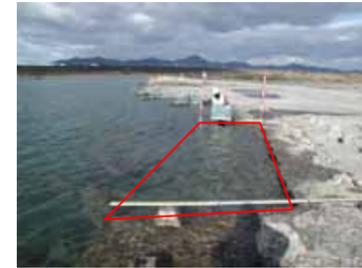
流出  
05-1001

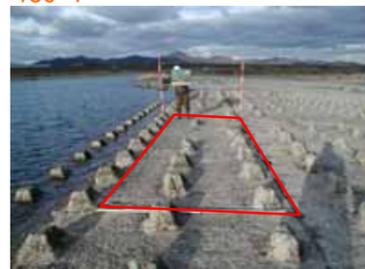
150-1

破損

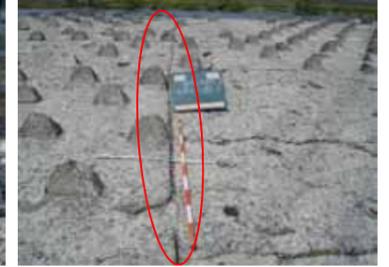
171-2

隙間

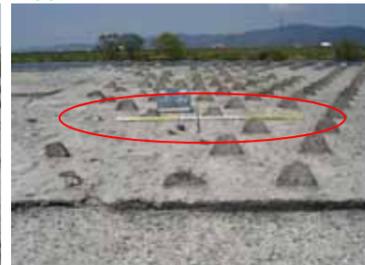
150-2

クラック

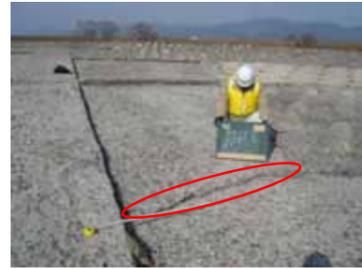
クラック  
195-2

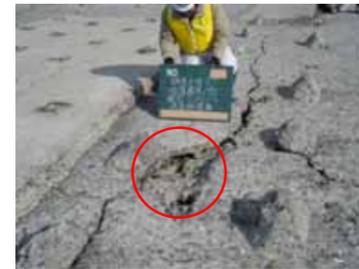
破損  
195-1

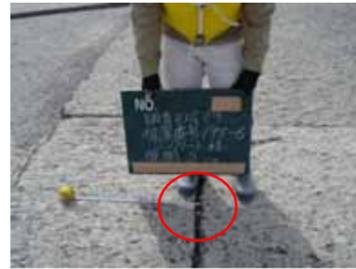
198-6

隙間

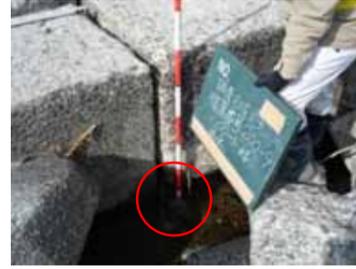
200-9

漏水

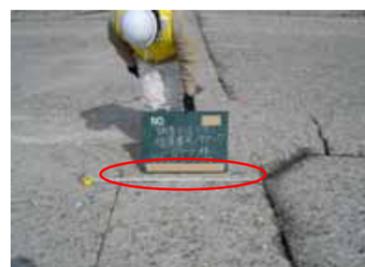
198-5

クラック

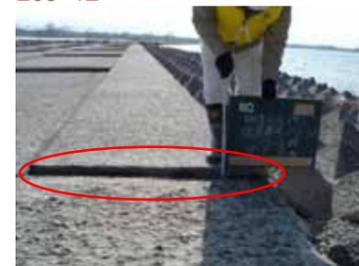
クラック  
205-11

沈下  
205-12
