第十堰調査区域詳細図

調査区域15 植石コンクリート

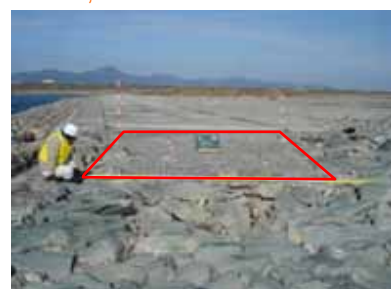
破損
208-1,210

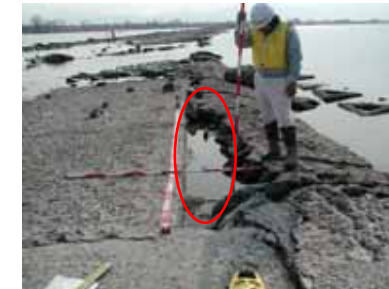
流出
05-1501

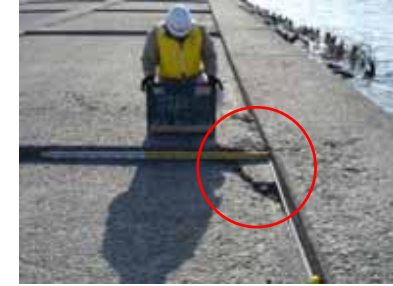
212-1

破損

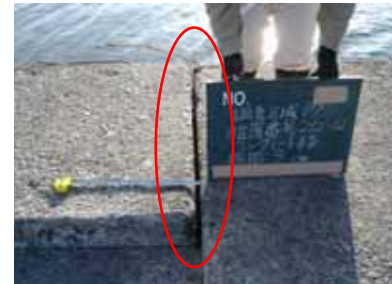
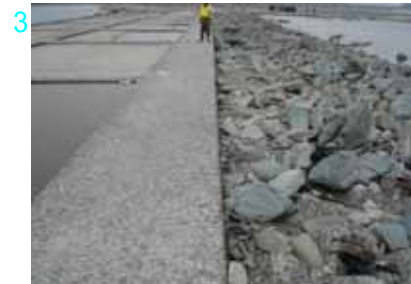
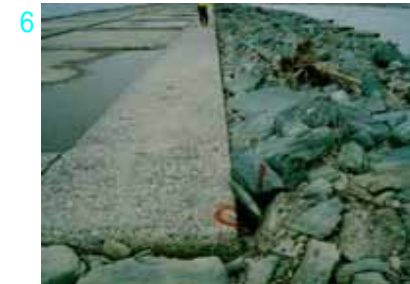
212-10

隙間

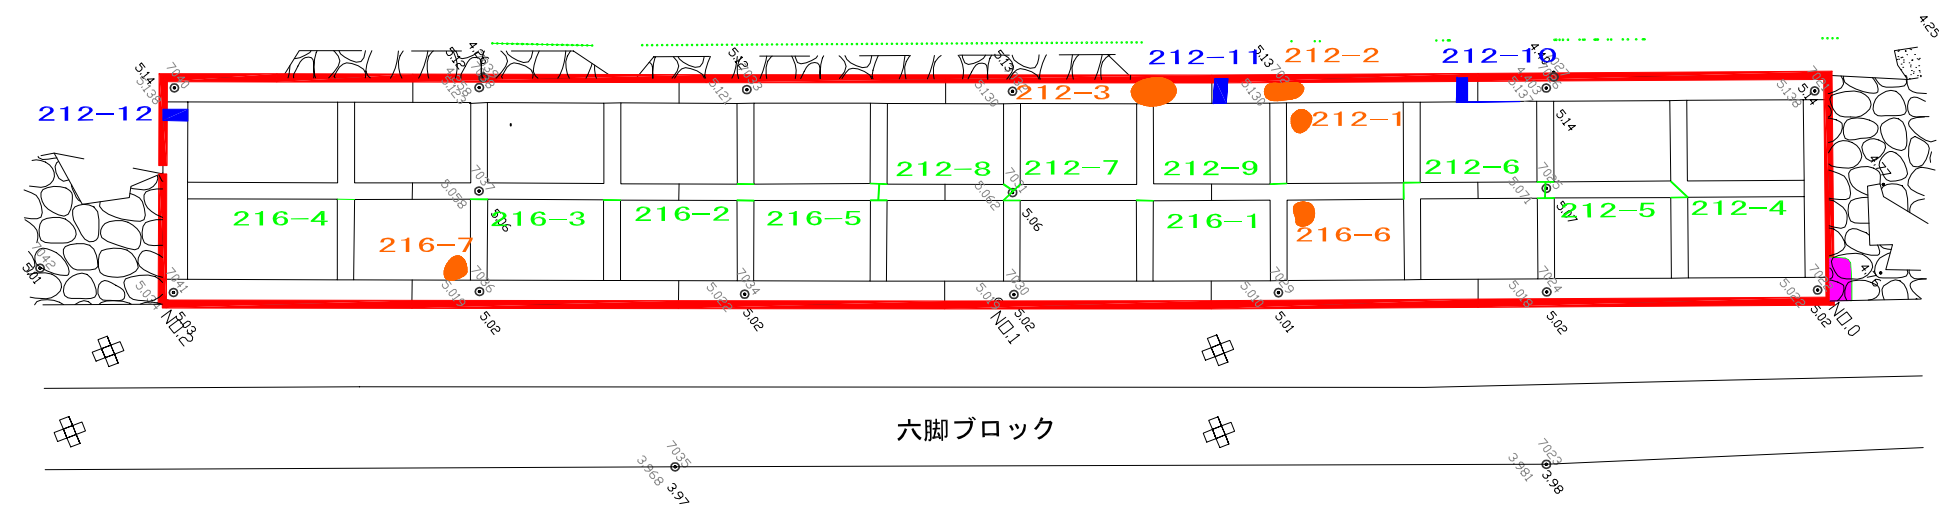
調査区域 17 コンクリート張 (2/2)

クラック

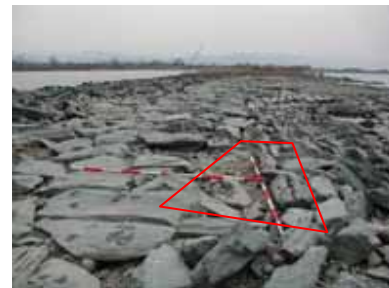
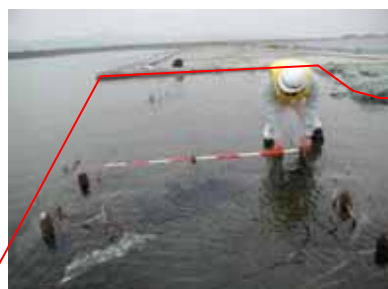
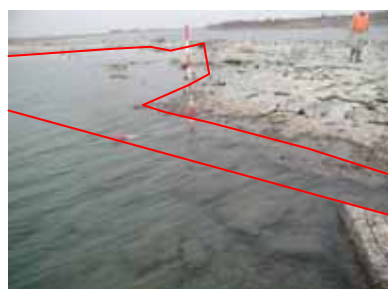
流出
05-17-1-01

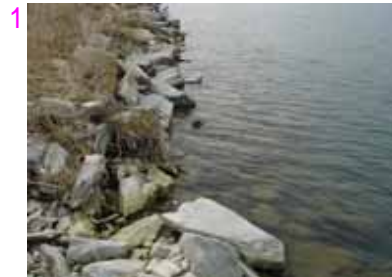
上流側

流出

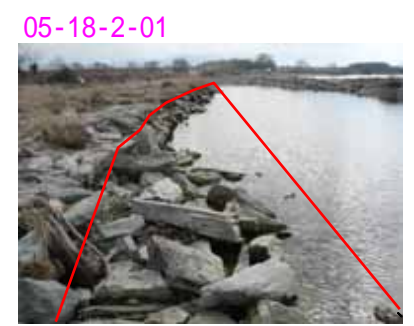
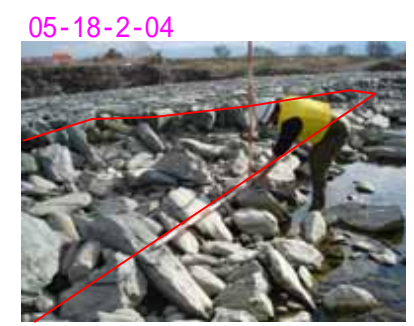
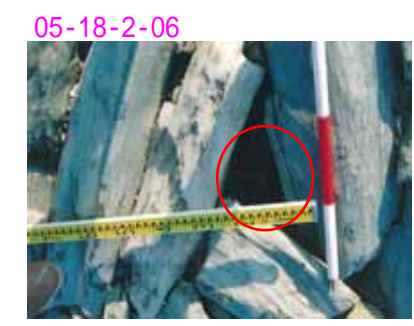
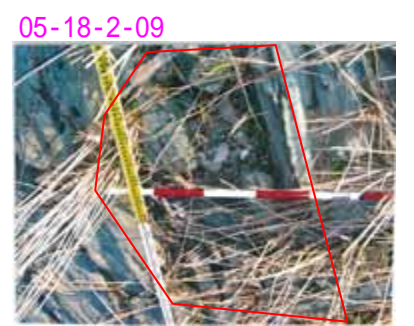
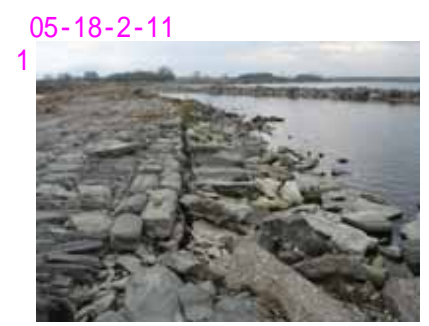
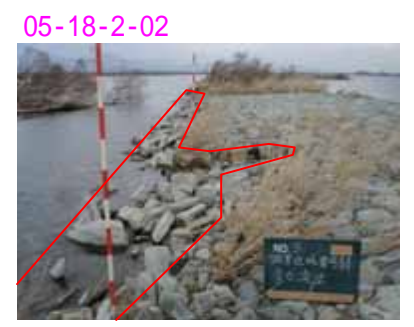
調査区域 18-2 青石張 (1/2)

流出
