第十堰調査区域詳細図

調査区域 27 魚道

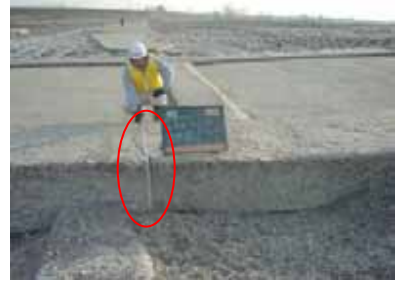
154-2

クラック

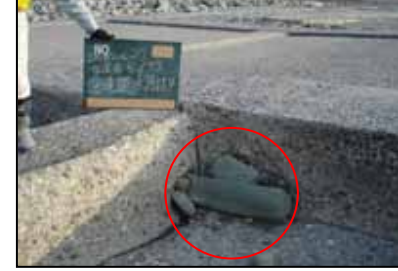
153-2

水路詰り

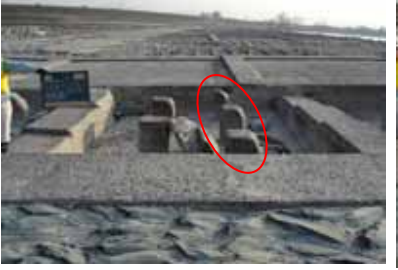
153-1

破損

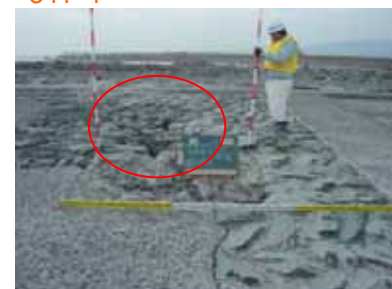
341-1

破損

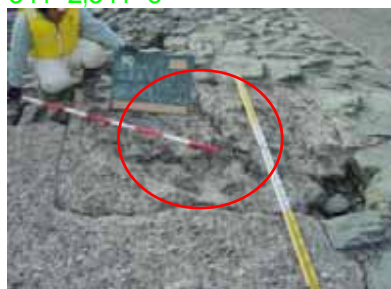
341-2,341-3

クラック

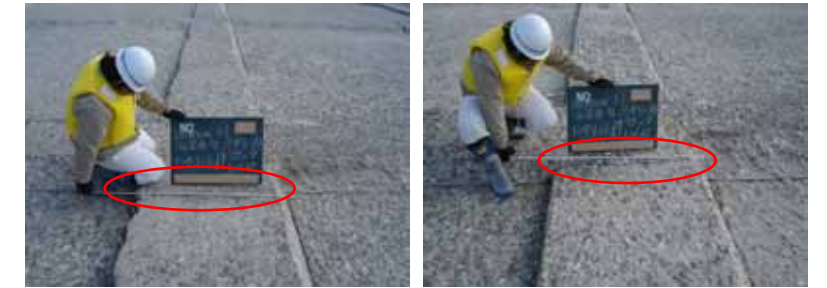
348-14

クラック
348-13

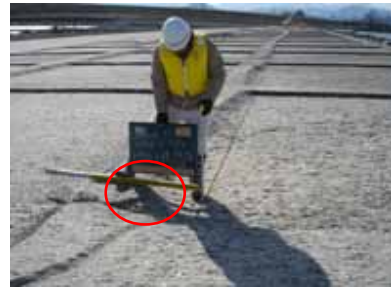
破損
348-1

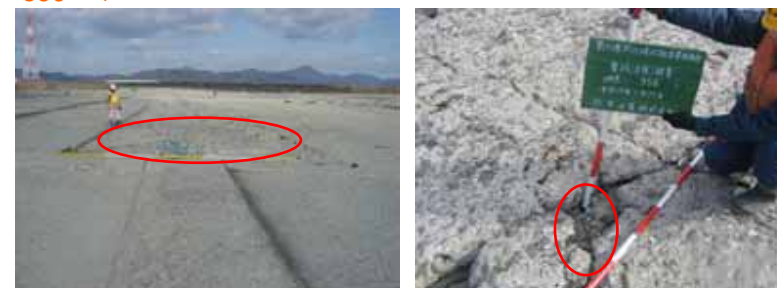
破損
356-1

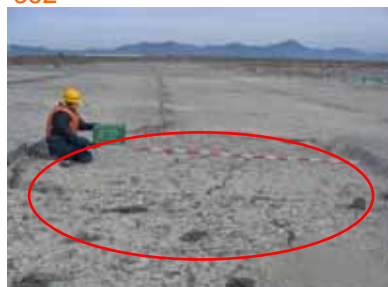
352

破損

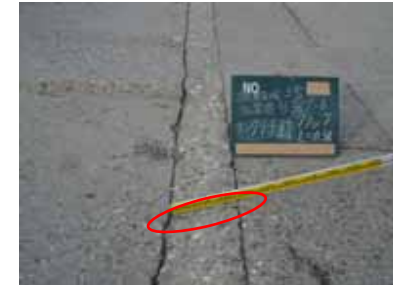
367-6

クラック

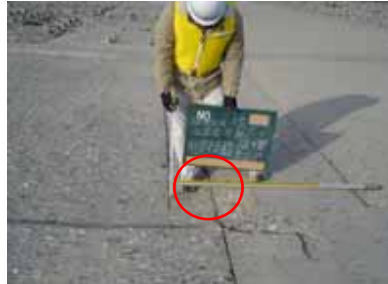
367-1

破損
