第十堰調査区域詳細図

調査区域 2 コクリト張

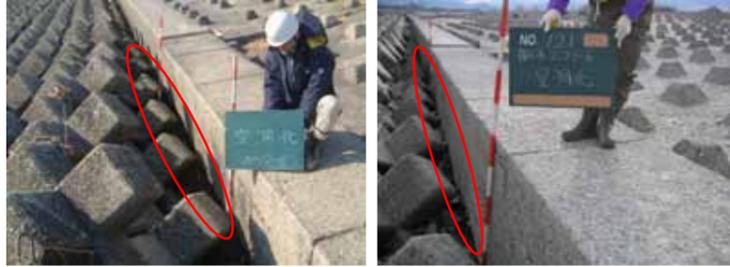
空洞
121

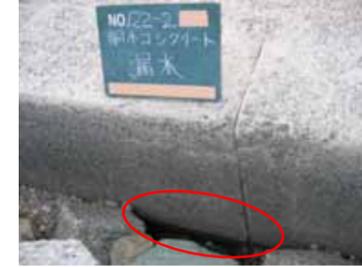
漏水
122-2

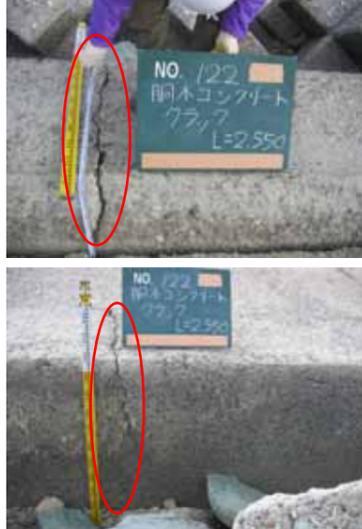
クラック
122-1

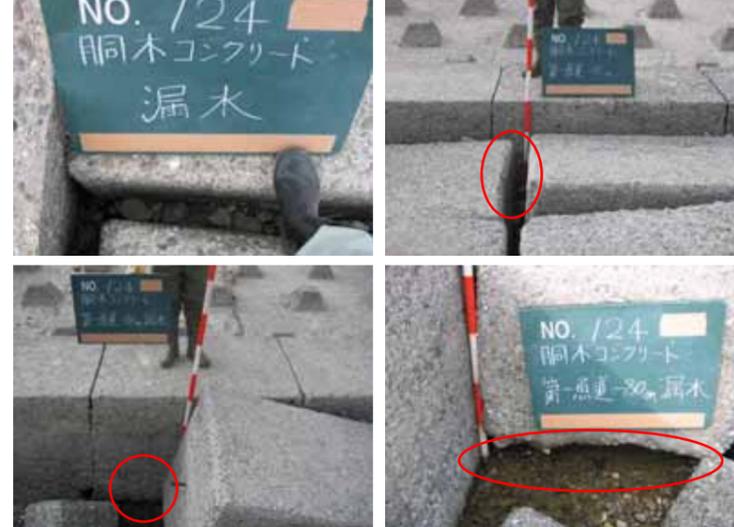
漏水
124

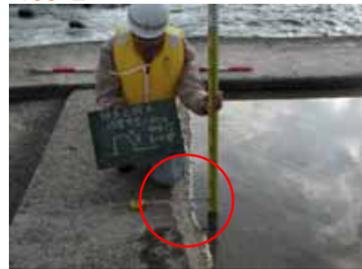
破損
130-2

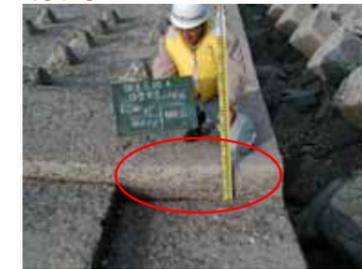
沈下
134-6

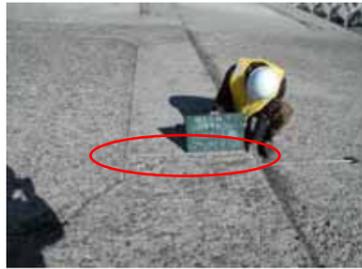
クラック

156-1

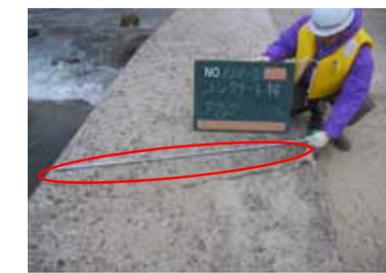
クラック
139-2

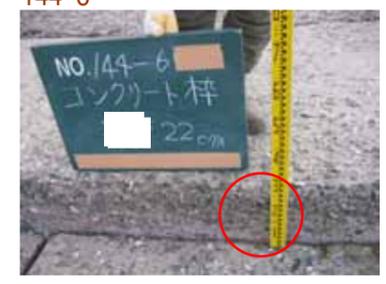
沈下
144-6

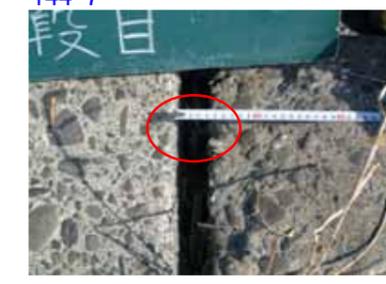
隙間
144-7

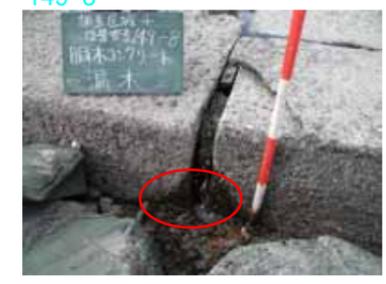
漏水
149-8

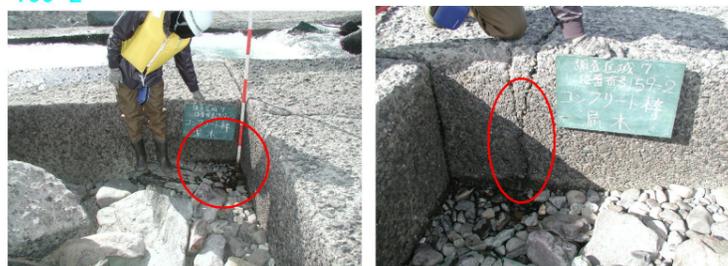
漏水
159-2
