第十堰調査区域詳細図

調査区域 19 植石コンクリト(1/2)

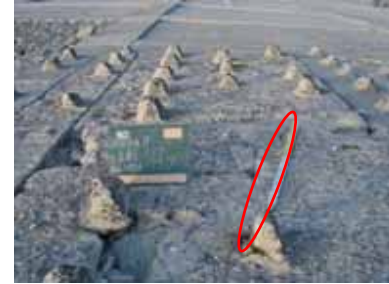
227-3

クラック

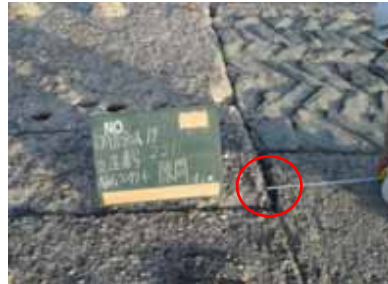
221-2

隙間

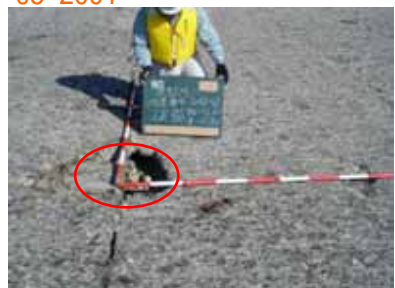
**破損**  
241,242-1,244

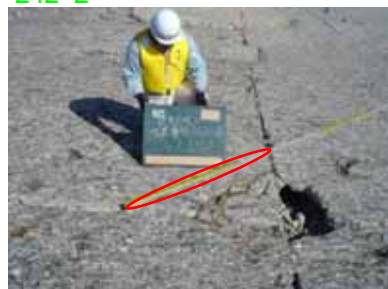
**クラック**  
242-2

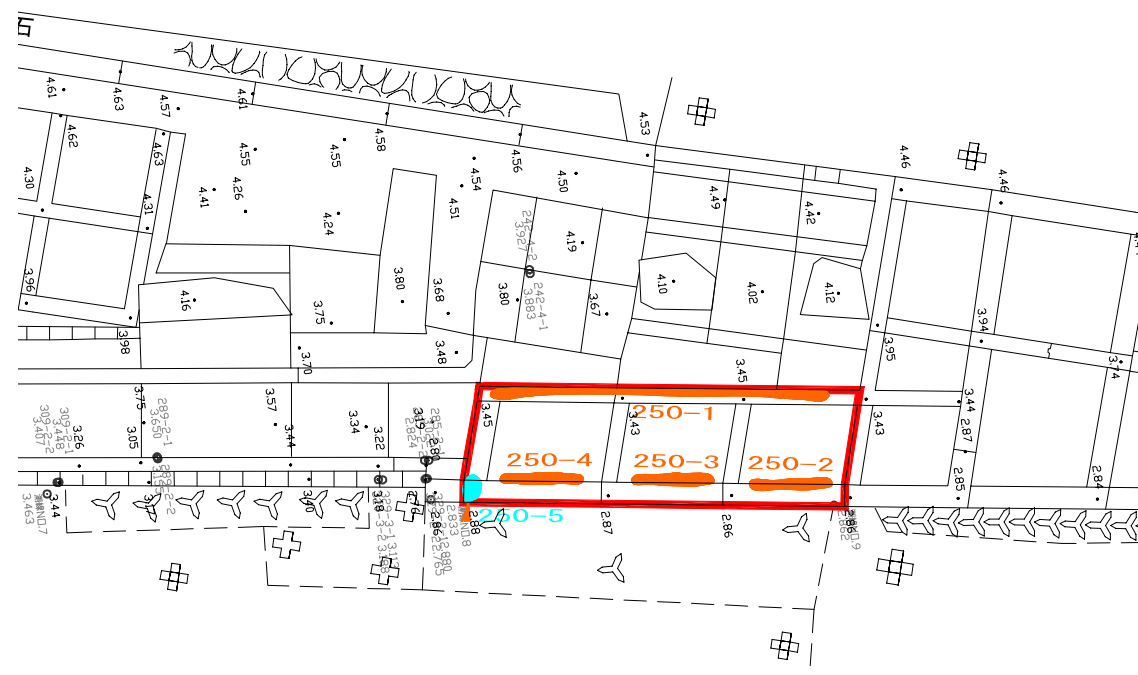
破損

漏水

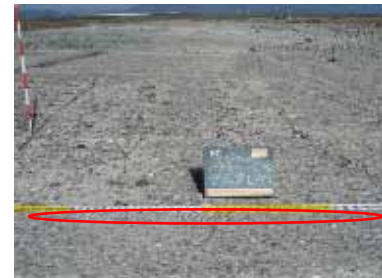
破損

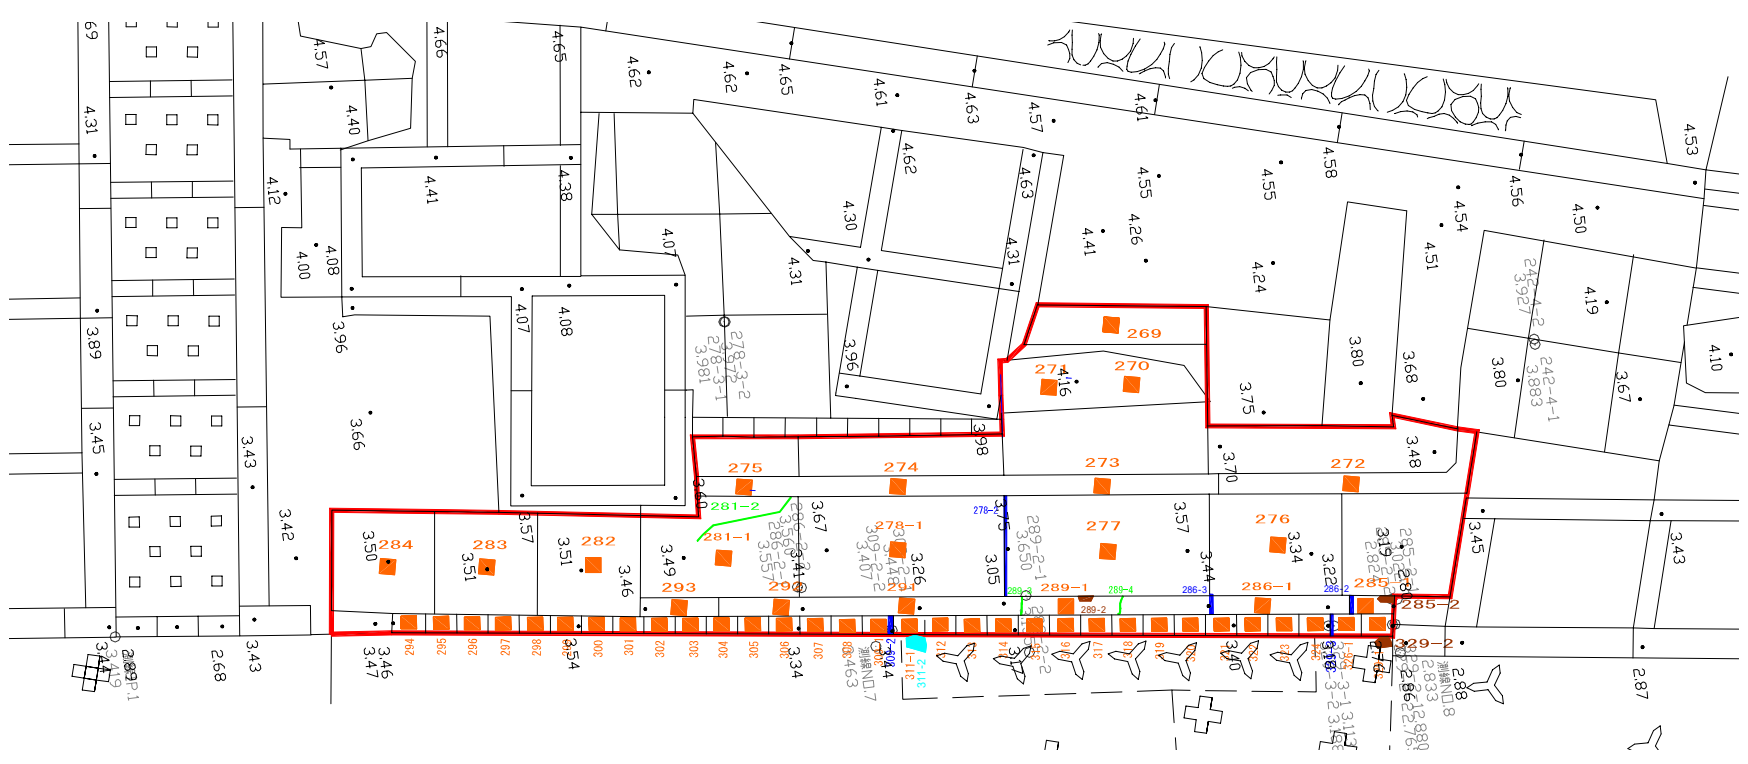
破損

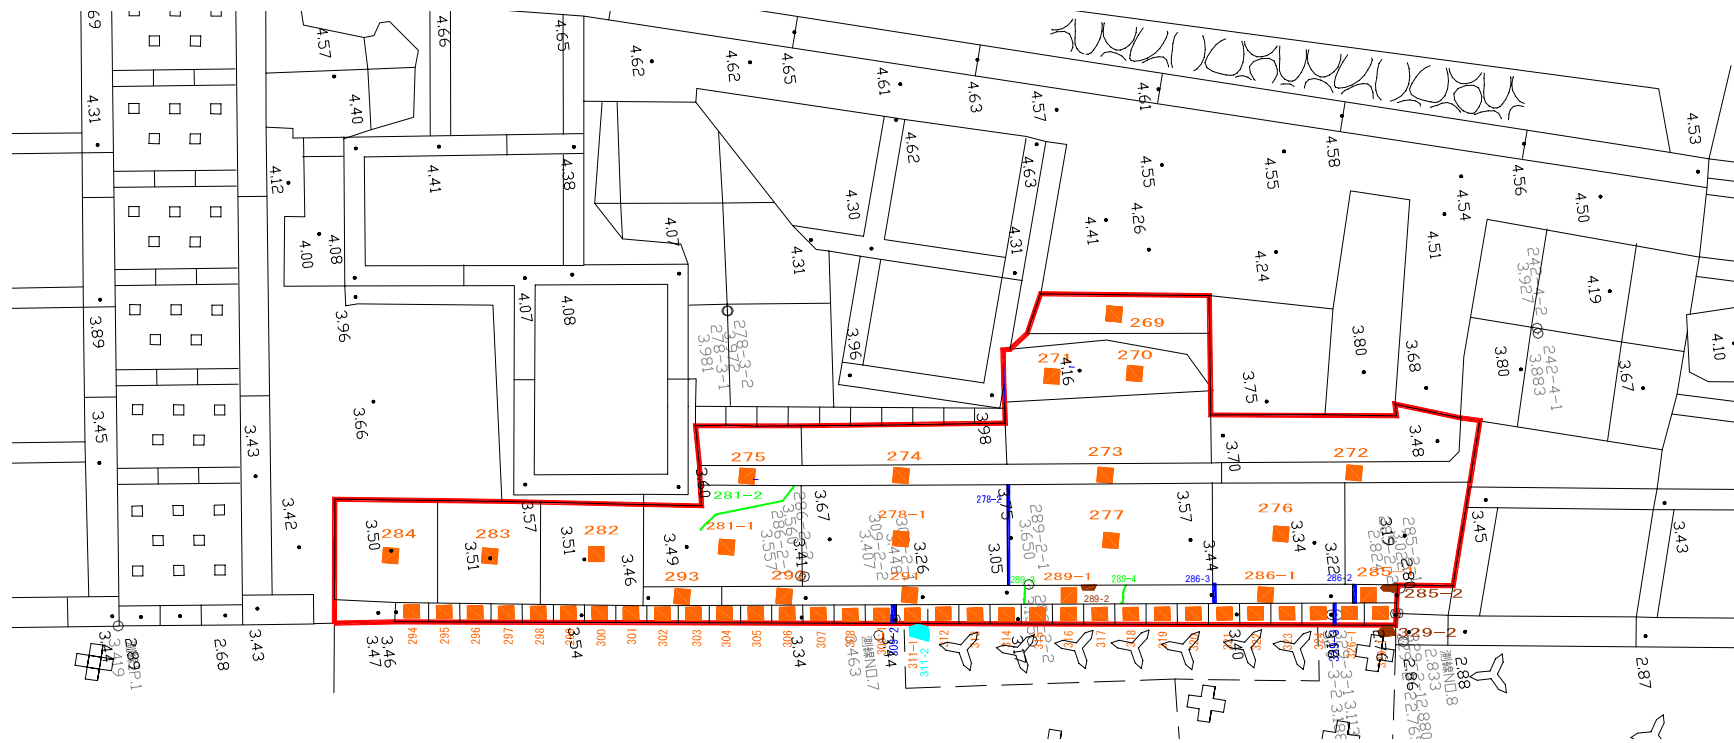
破損

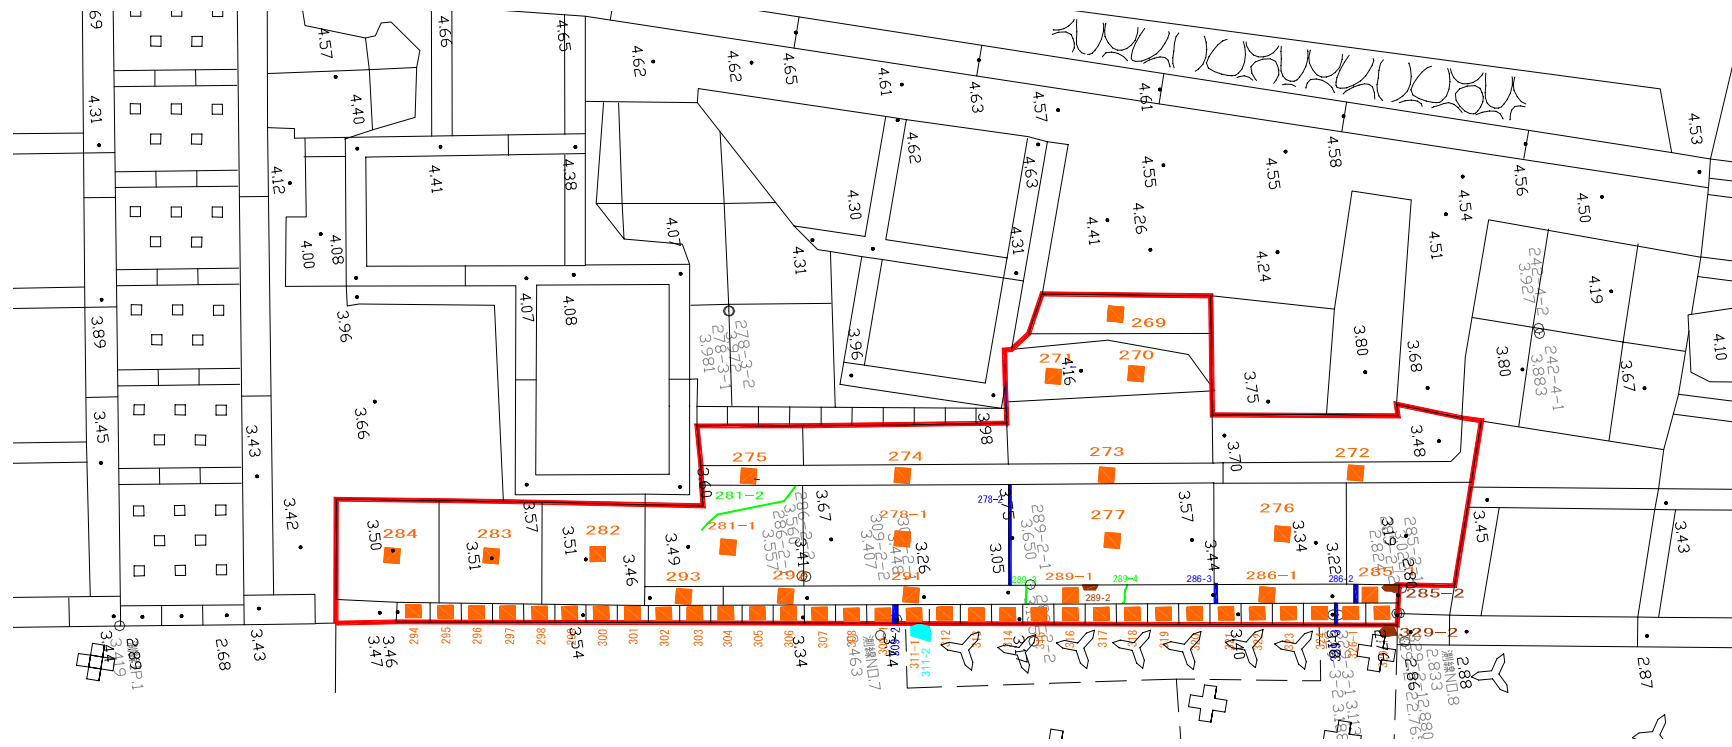
調査区域 24 植石コンクリト (3/4)

破損

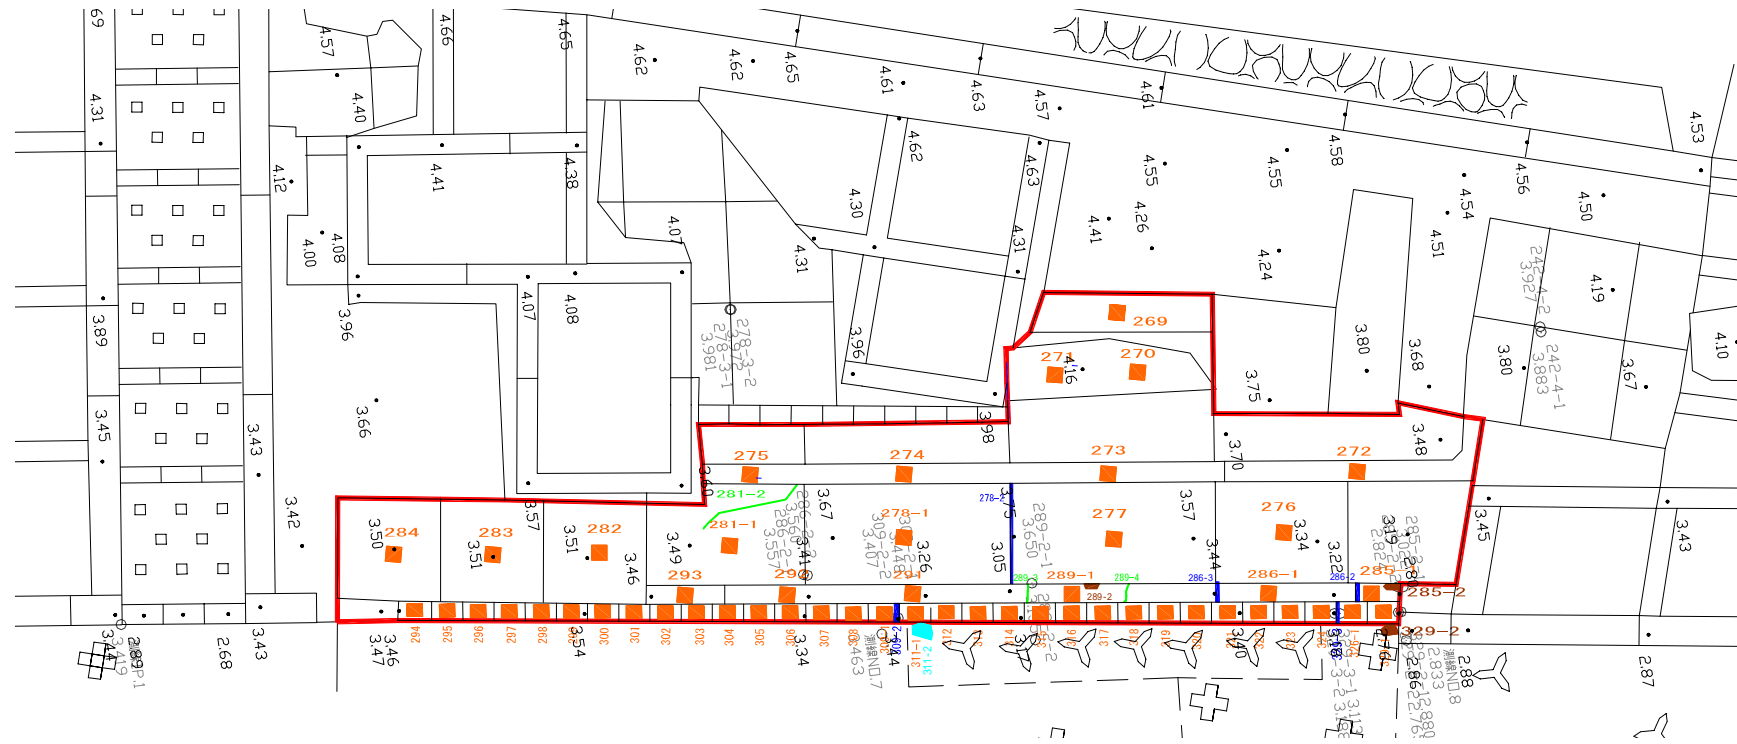
調査区域 24 植石コンクリト (4/4)

クラック

沈下

漏水

隙間

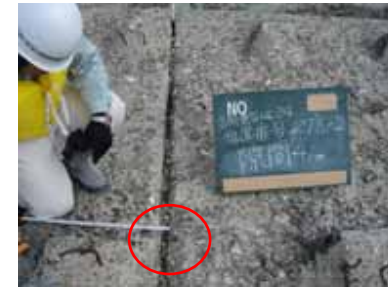
278-2

隙間

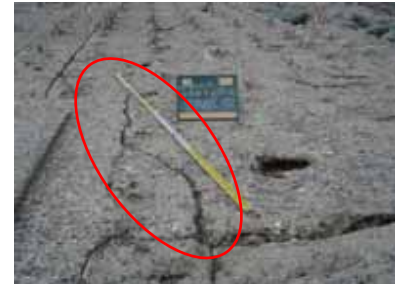
281-2

クラック
