第十堰調査区域詳細図

調査区域 36 植石コンクリート(1/3)

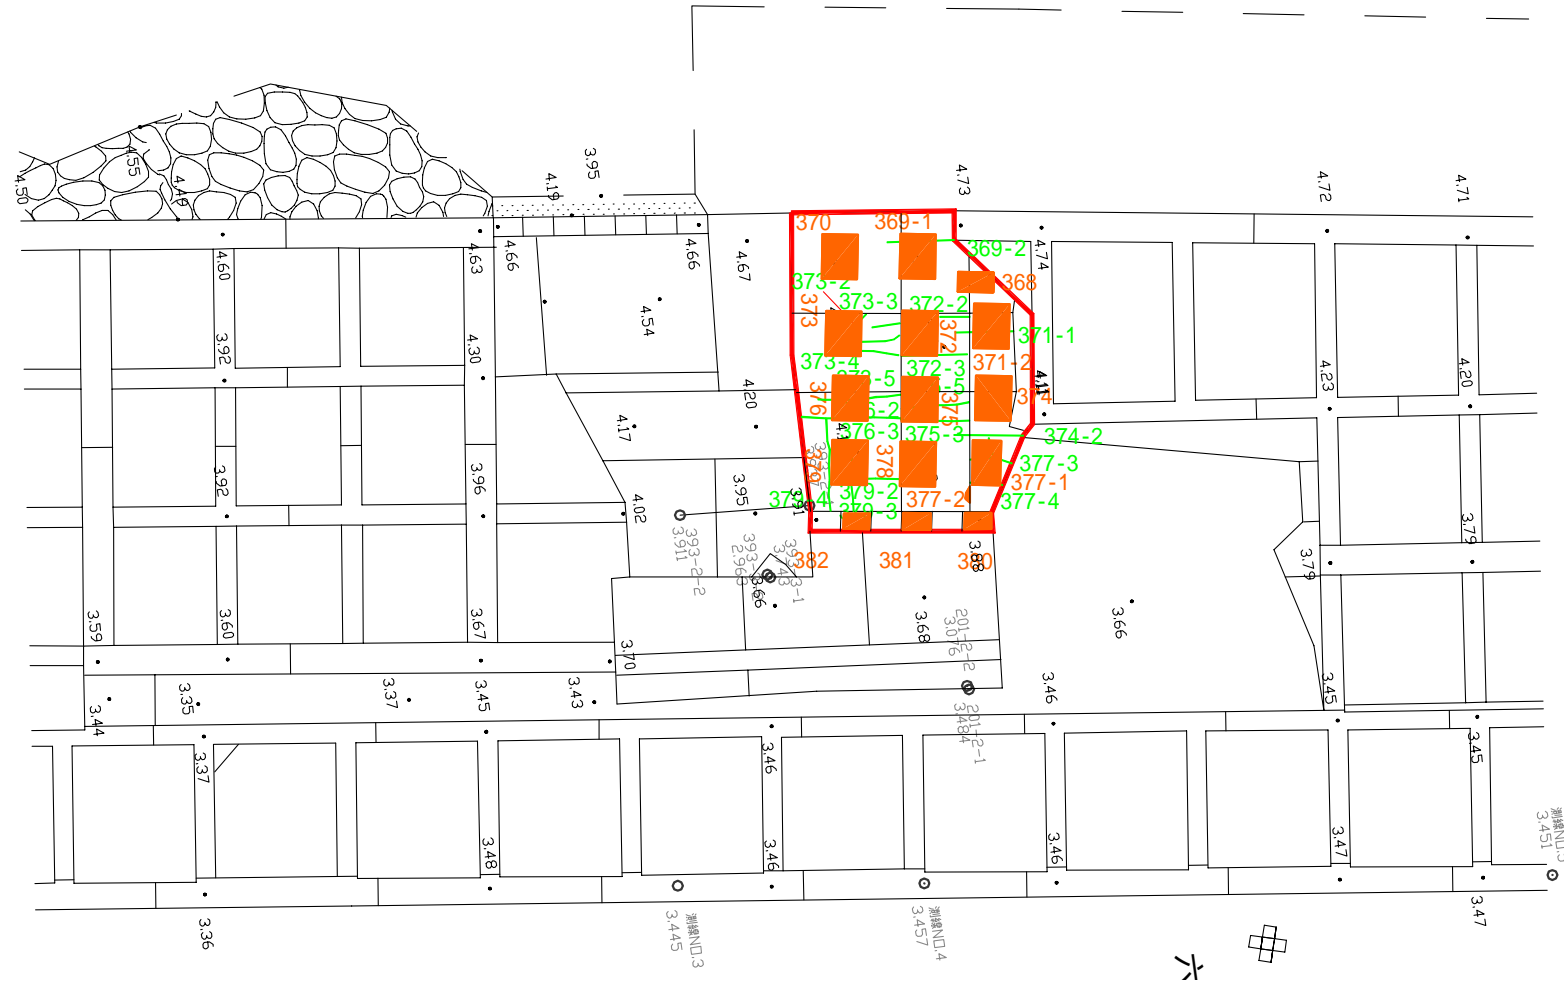
調査区域 36 植石コンクリート(3/3)

クラック

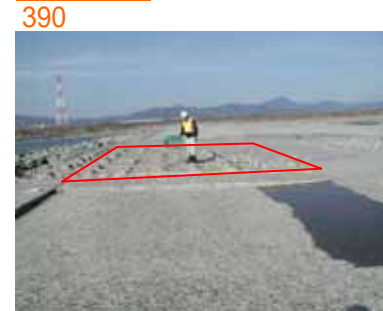
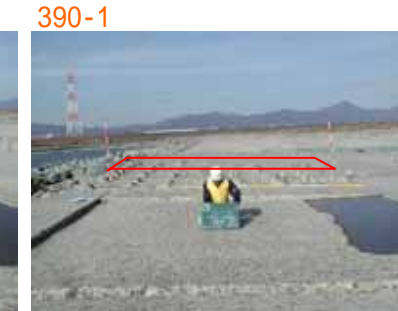
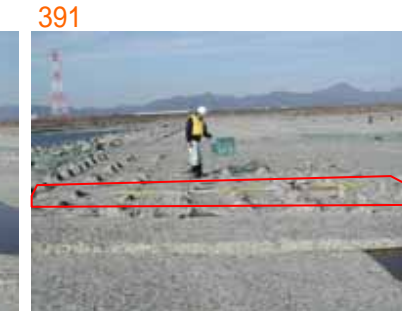
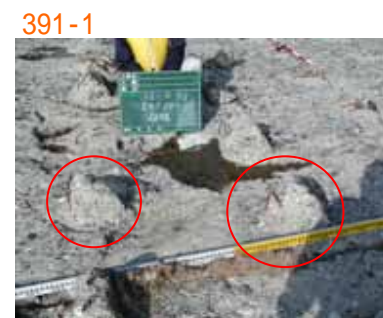
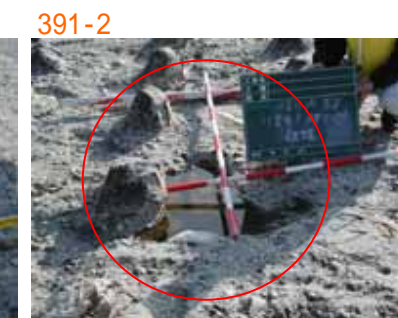
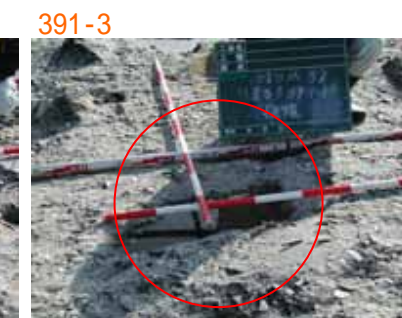
調査区域 37 植石コンクリト

破損

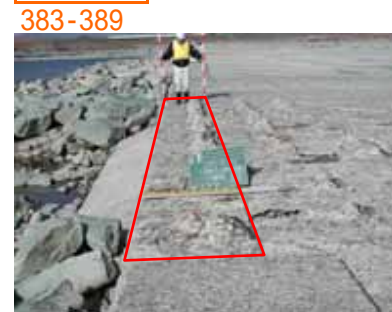
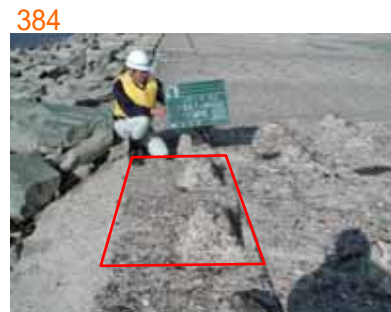
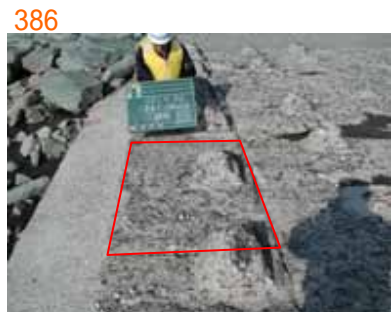
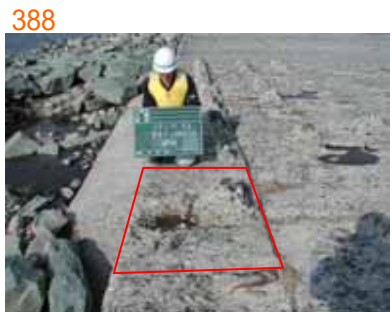
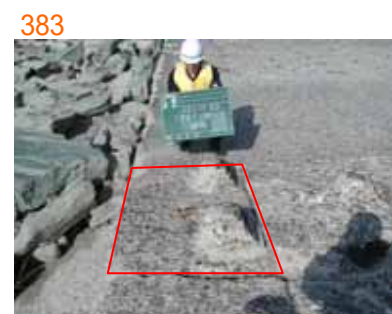
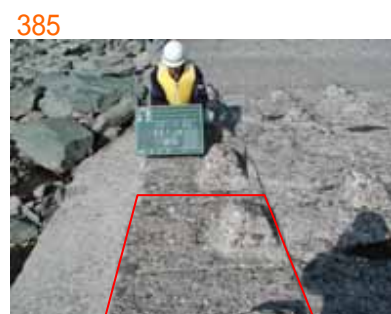
破損

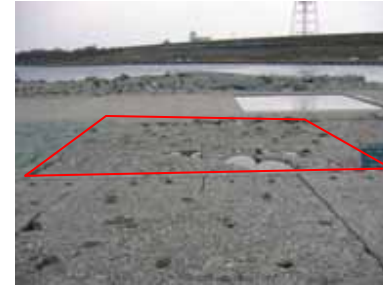
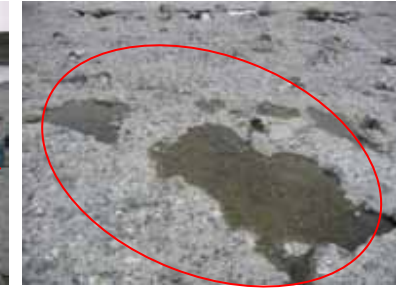
393-1

破損

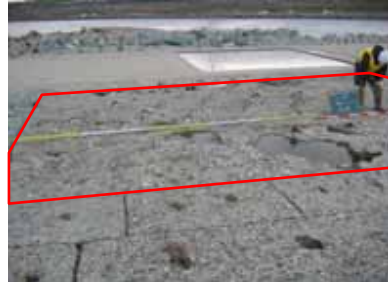
172

破損

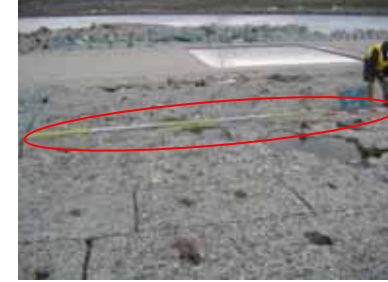
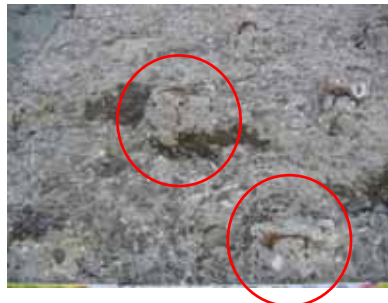
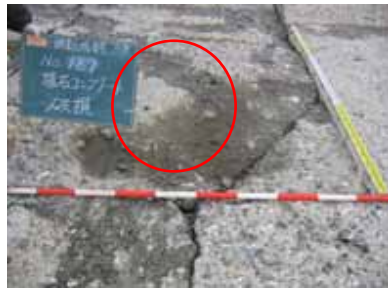
393-2

クラック

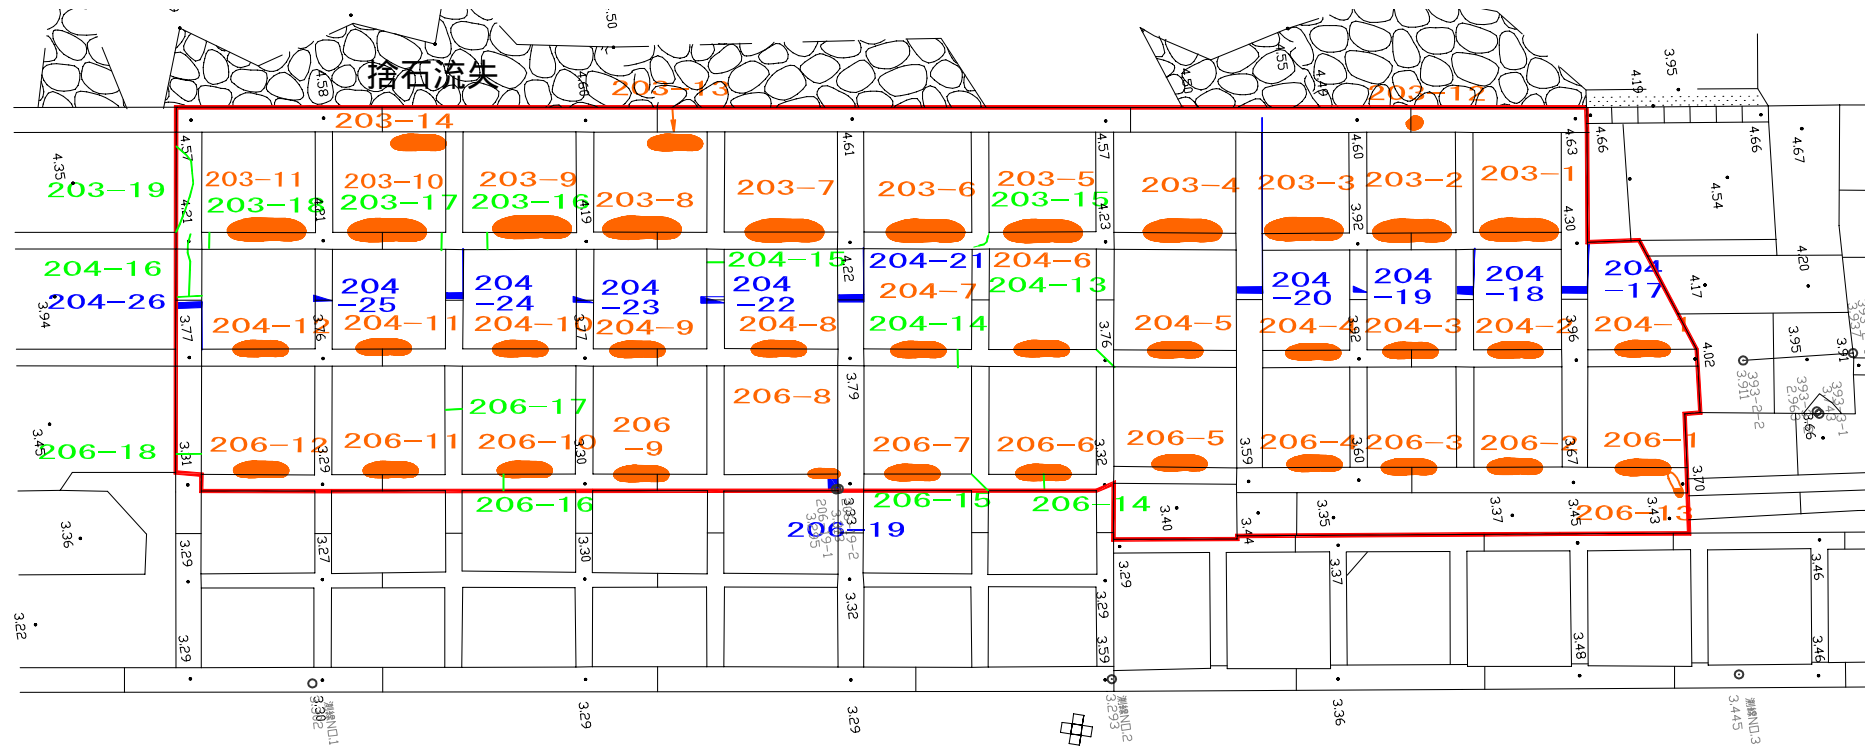
## 調査区域 40 コンクリート張 (3/4)

クラック

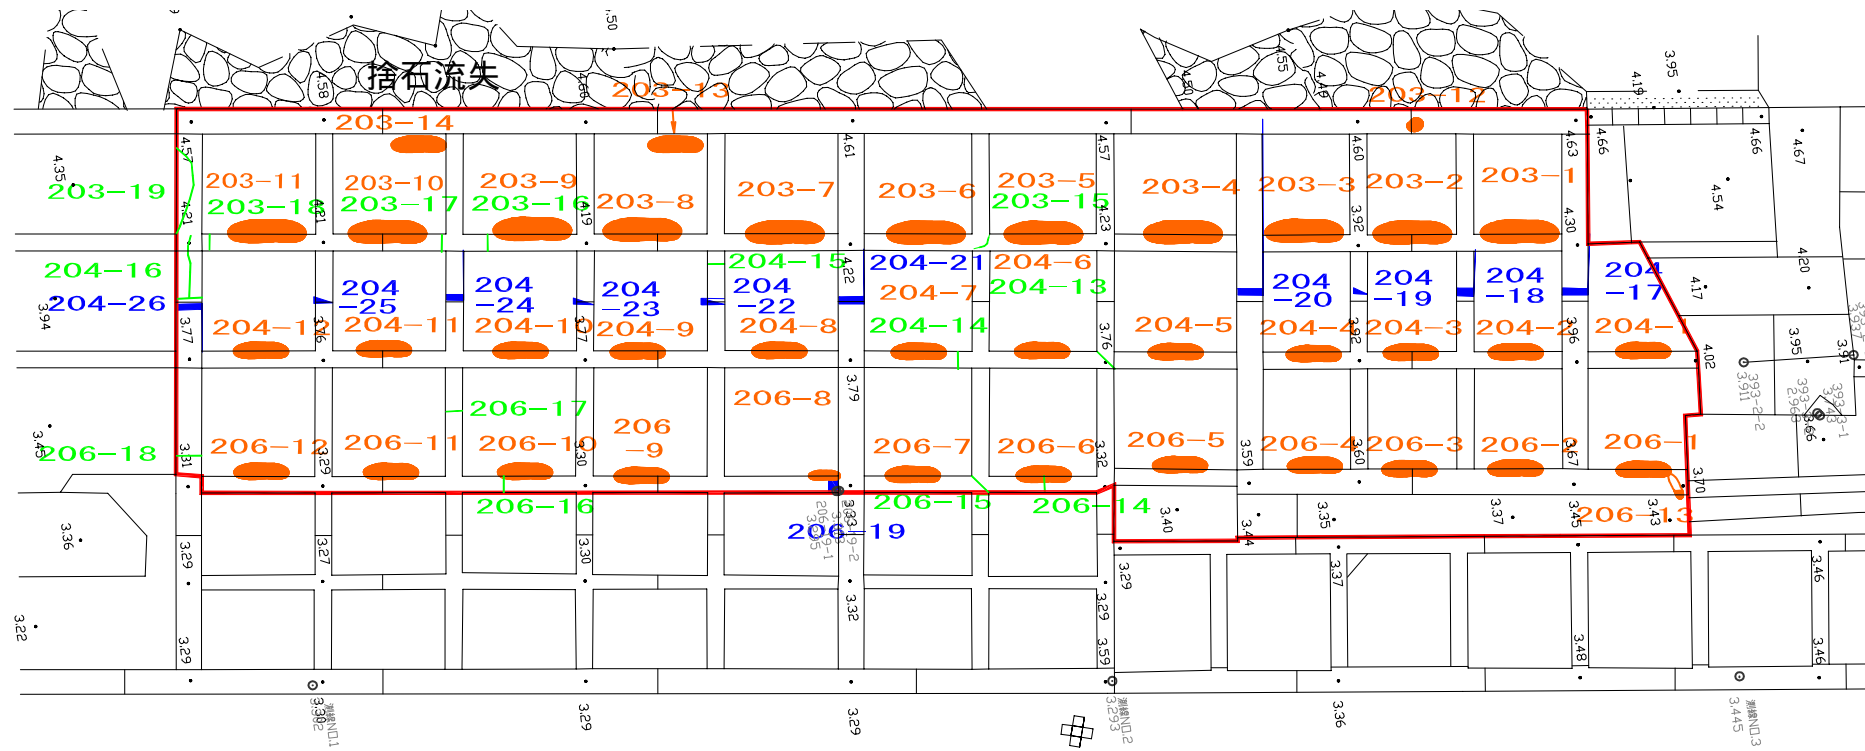
調査区域 40 コンクリート張 (4/4)

隙間

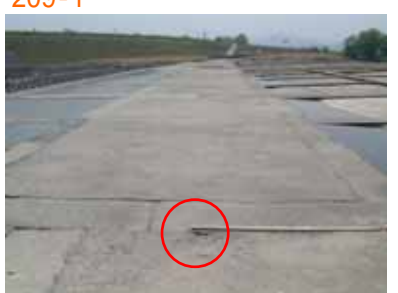
209-1

破損

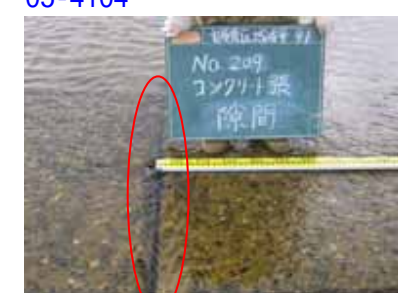
05-4104

隙間

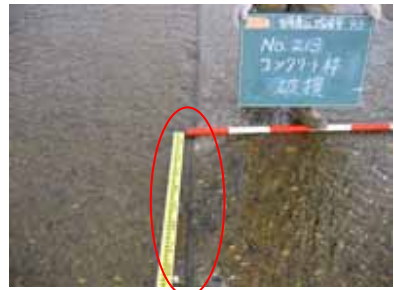
05-4301

破損
