第十堰調査区域詳細図

調査区域 8 魚道

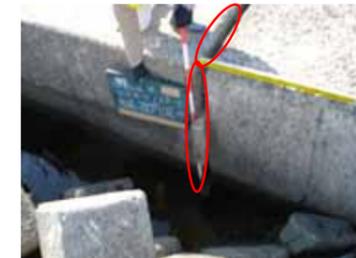
163-2

隙間

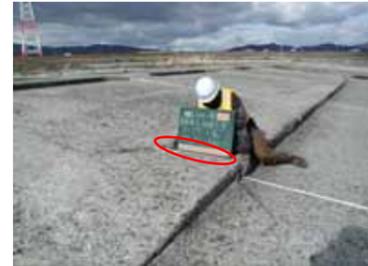
164-2

クラック

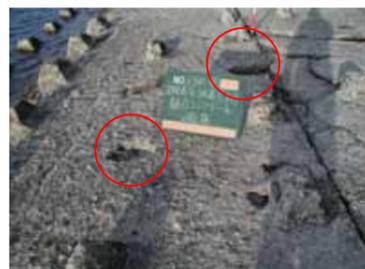
150-1

破損

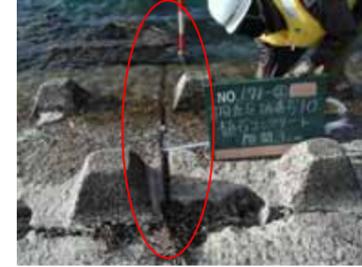
171-2

隙間

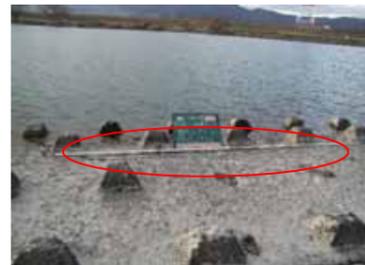
150-2

クラック

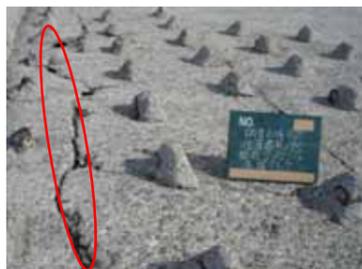
195-3

クラック  
195-2

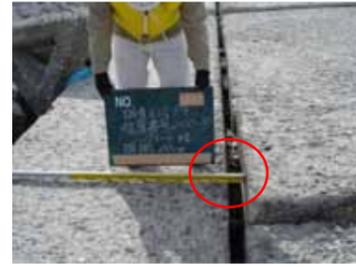
200-10

漏水

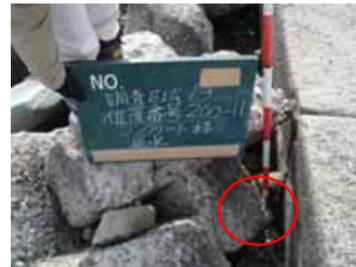
クラック

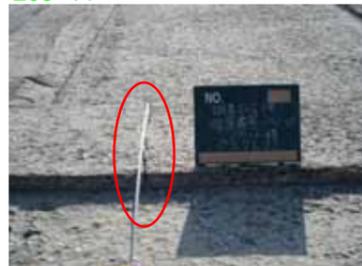
沈下  
205-12
