第十堰調査区域詳細図

調査区域15 植石コンクリート

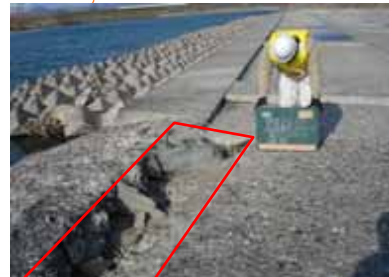
破損
208-1,210

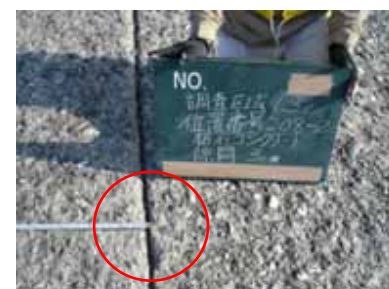
隙間
208-2

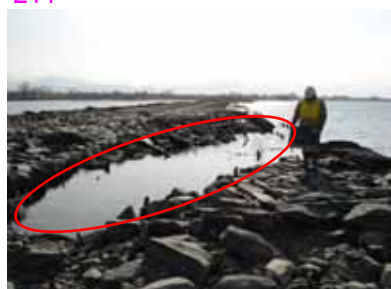
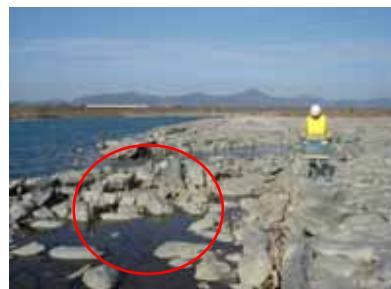
211

流出

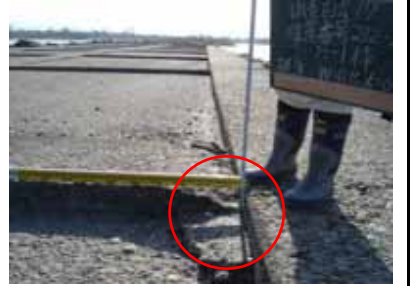
212-1

破損

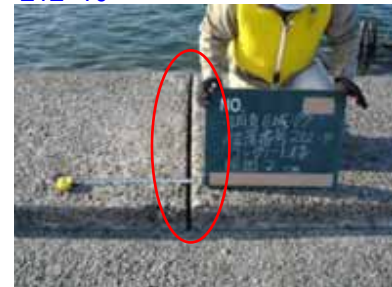
212-10

隙間

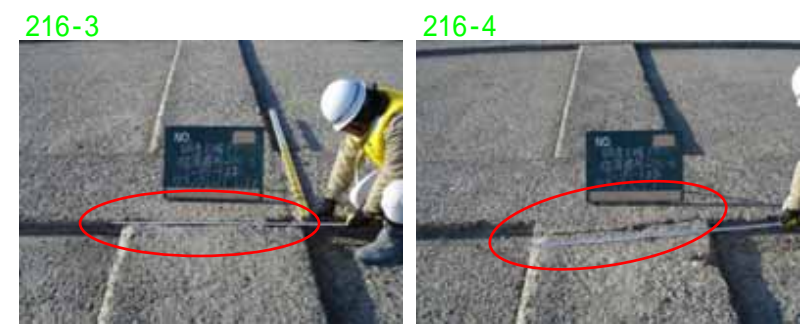
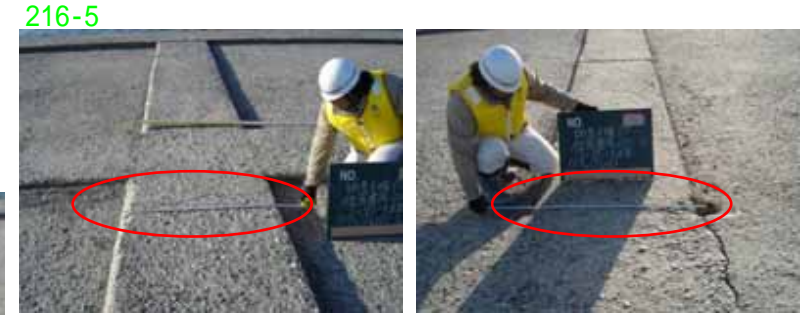
調査区域 17 コンクリート張 (2/2)

クラック

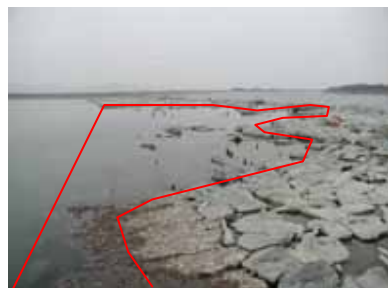
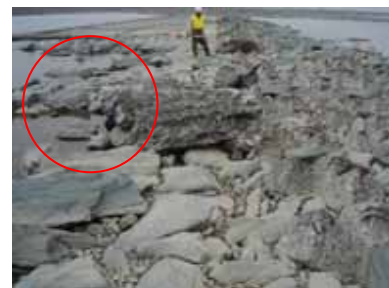
流出
05-17-1-01
