第十堰調査区域詳細図

調査区域 27 魚道

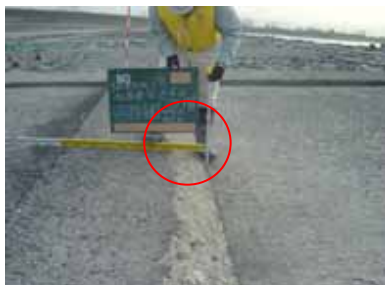
340-1

破損

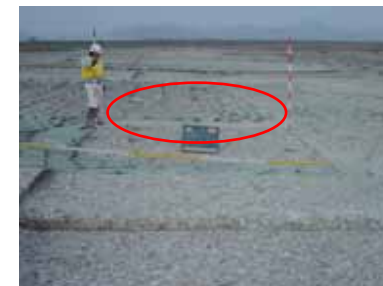
347

破損

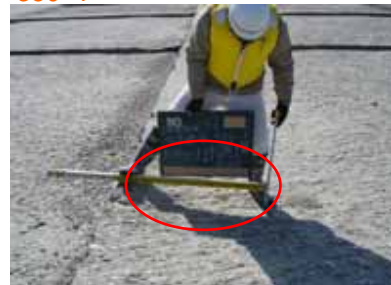
350-1

破損

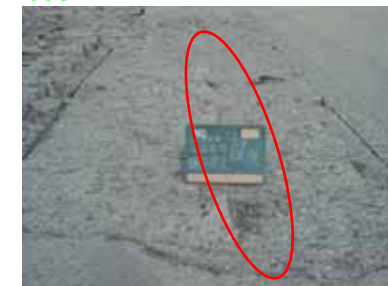
356-2

クラック

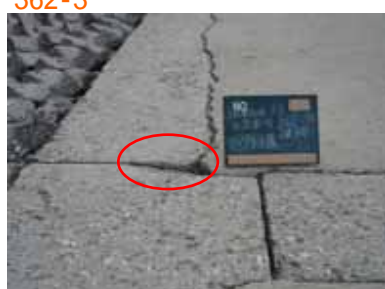
362-3

破損

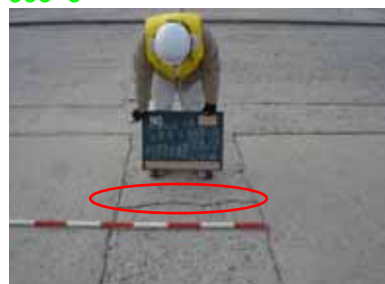
363-3

クラック

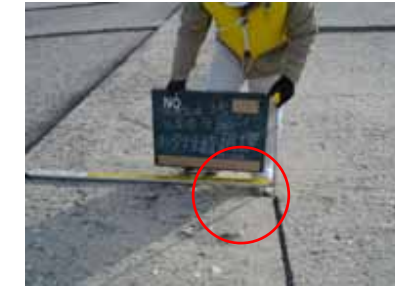
366-1

破損

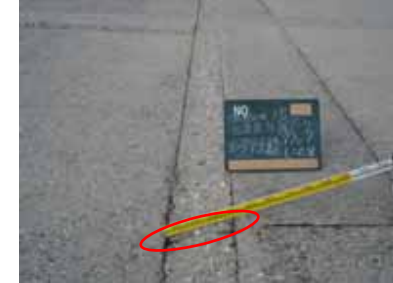
367-7

クラック

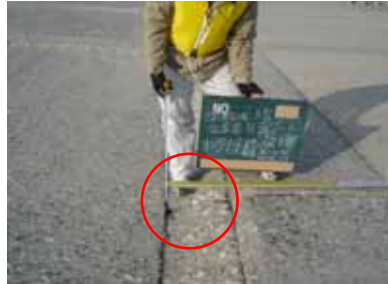
367-3

破損
