第十堰調査区域詳細図

調査区域 2 コクリト張

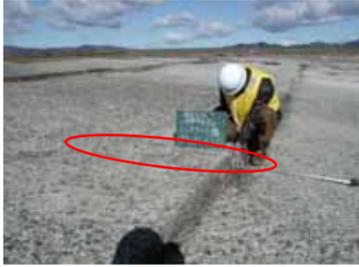
156-1

クラック

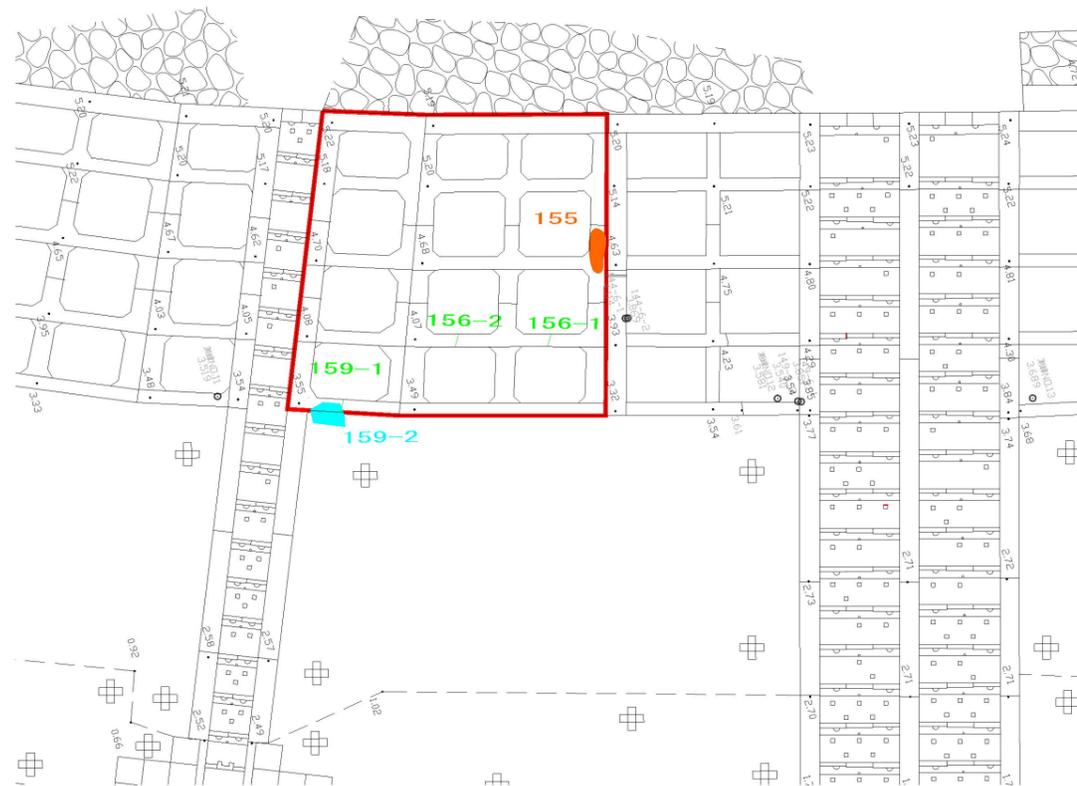
漏水 破損 クラック

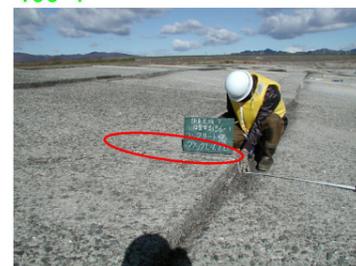
クラック
156-1
